River Valley Home Inspections LLC

It was a pleasure completing your property inspection. As you will read, the inspection report consists of a detailed evaluation of different components and elements present in and outside the property with photographs of the property.

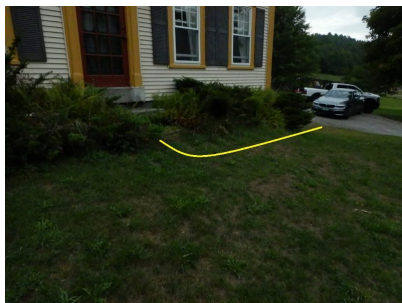
~Walkways Established: Walkways from the drive area and between entry points of the home should be established; Continuous walks allow people to move safely across lawns and open areas especially during winter and rain events.

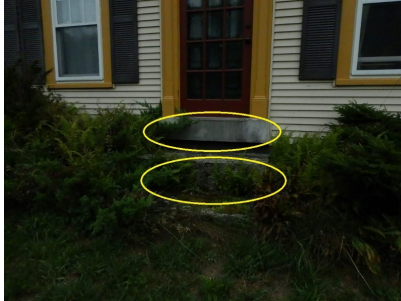
Front Step.

~Steps Risers Too Tall: The current steps are too tall and exceed the 7- 3/4 inch maximum height; Steps in this condition may lead to a tripping hazard and should be repaired; A properly sized landing will need to be incorporated into the step structure.

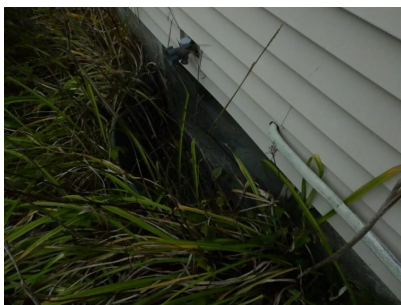
~Clean, Stone, Cover: All window well openings should be cleaned and emptied of all leaf material and debris to allow for drainage and drying of the window well area; Stone added in the base of the window well and covers or small roof structures added to shed water away from the home will aid in keeping the window wells clean and improving drainage of water away from the foundation of the home.

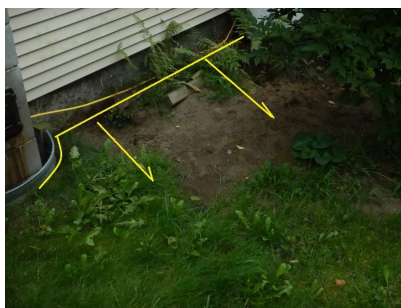
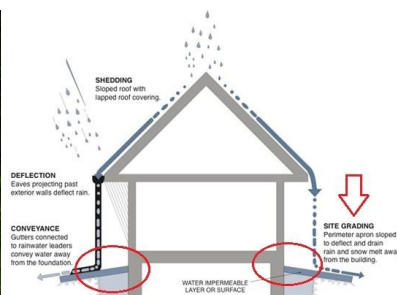
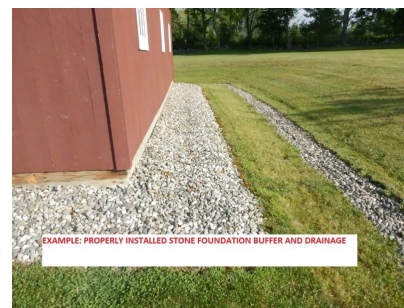
~Ledge Basement Homes: Ongoing General Grading Needs: An important factor in helping to control moisture in homes with ledge/stone basements is proper grading and allowing water to flow away from the home's siding, sills and foundation; A plan should be implemented to upgrade the current grading along the foundation including any planting beds of the home; Grading first with vapor barrier with stone on top should be added to allow water to flow away from the foundation and limit dirt and water splashing onto the siding of the home; The top of the stone border should be at least 6 inches below the edge of the siding when establishing the grade of 5/8th inch pitch per foot fall and/or drained to move water away from the foundation.

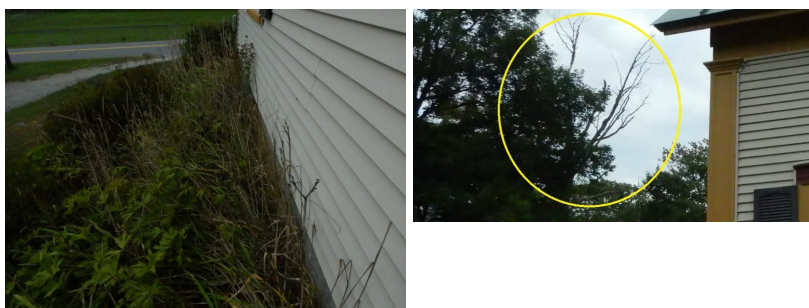
~General Tree Care: The home is surrounded by larger trees; The trees should be fully assessed by a tree professional to determine the health and structural integrity of the trees including the removal of any dead or declining trees or dead and declining branches that may fall from the living trees; It is especially important to remove tree branching overhanging roofs that may damage roofs or allow for the development of moist roof condition promoting the growth of moss and lichens on the roof surface; Tree health and integrity should be monitored especially after storm events to include heavy wind, heavy snow or ice.

~Remove Vegetation: All vegetation and tree branches within at least 2 feet of the home, 6 feet is preferred, and buildings including the garage needs to be removed; Vegetation close to homes allows moist conditions to form along the home promoting decay and algae growth as well as harboring pest that may find there way into the home; Additionally, tree branches do not allow roof surfaces to dry promoting roof moss and falling branches will damage roof surfaces.

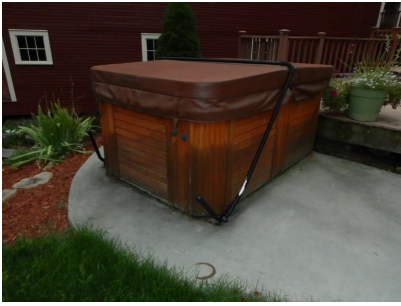
~Spa Installed At Home: While not a part of the home inspection protocol, safety features for spa installation has advanced to include specific home and water entrance alarms as well as locking spa covers and other safety features installed to keep individuals from entering spas accidentally when not monitored or in use; It is encouraged to have the spas current safety features reviewed to include all spa electrical grounding systems, current safety features and new advancements in spa safety explored for possible implementation.

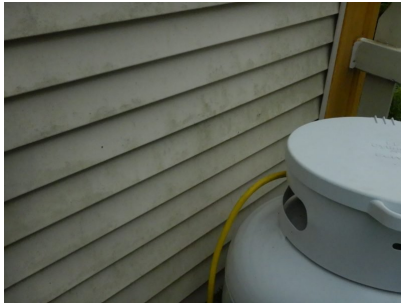
Clean

remove dirt and algae from the siding; This cleaning practice on this common condition allows the siding to remain free of algae and dirt that can form on vinyl siding over time.

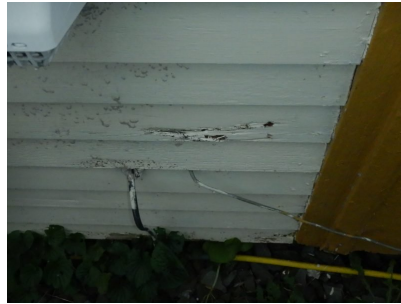
~Wood Siding Decline: Baseline Repair and Ongoing: Areas of siding decline was observed on the rear of the home as a result of moisture and snow contact over the years; Wood sided homes need to be reviewed yearly and the damaged siding repaired to eliminate further decline of the remaining siding as well as protecting the structure behind the siding from further damage due to water penetration; Please note: the wall sheathing, 2X4 wall studs and sill behind the siding should be checked for damage when the siding is removed and repaired in these areas if damage is identified.

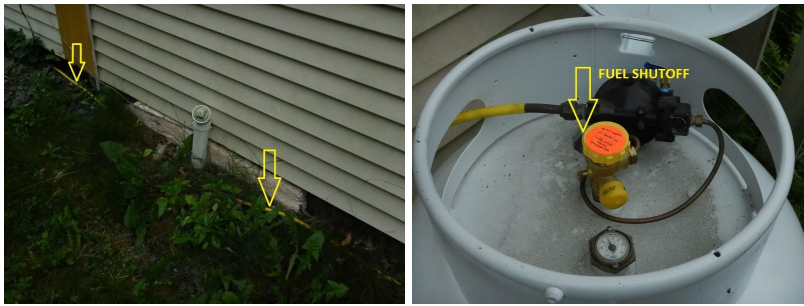
~Secure Gas Lines To Home: The propane lines running along the home's perimeter in the beds needs to be properly supported and attached to the home.

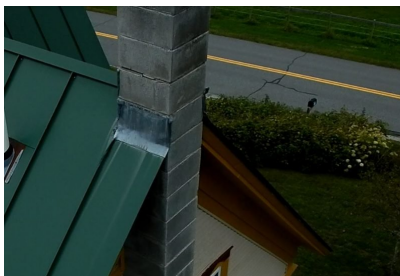
Block Fracture and Joint Repair

~Cinder Block: Block Fracture: The rear block chimney(s) was observed with fractured upper blocks and some mortar deterioration on mortar joints in the area due to the freeze/thaw cycle; The chimney(s) damaged surface should be repaired to extend the life of the chimney(s) and avoid further damage; Visual observation is not enough and a professional chimney service should be consulted for the inspection and cleaning of the interior chimneys, caps added where needed and the surface sealed.

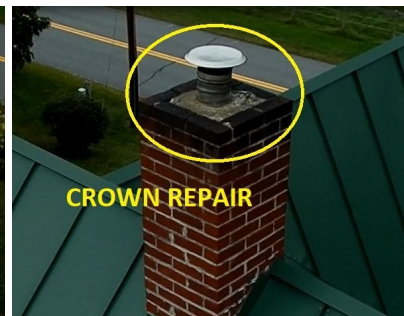
CROWN REPAIR

~Brick Pointing, Crown Inspection and Repair, and Cleaning: The brick chimney(s) was observed with some mortar deterioration on mortar joints at the top of the chimney and crown; The chimney's surface and crown will need to be repaired to eliminate further decline over time; Exterior visual observation is not enough in the case of chimneys and a professional chimney service should be consulted for the interior inspection and cleaning of the chimney (s) before use; The chimney flashing (metal) and counter flashing will need to be inspected as part of the chimney service to ensure no water is entering the home from this area of the chimney; If not installed, weather- spark arrest- animal protection caps should be added to the chimney openings.

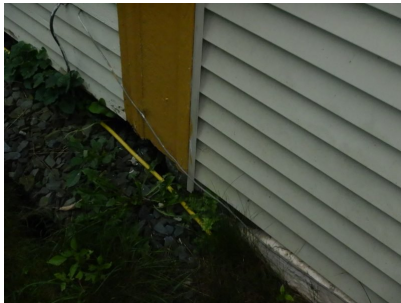
~Soft and Declining Wood Trim: Several small areas of the rear trim boards is decayed as a result of water penetration at the butt end cuts of the boards; The trim will need to be repaired and repainted to avoid further decline of those areas and eventual damage to other parts of the home behind the trim.

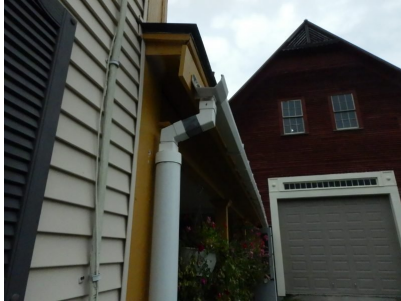
Add End Cap

~Ledge Basements: To aid in draining roof water runoff from around the home and foundation, gutters may be considered; Gutter type, size and strength is important in this geographic area; Gutters, downspouts and extensions need to withstand snow and ice sliding from roof surfaces and have the ability to catch and carry large amounts of water as a result of steep roof pitches.

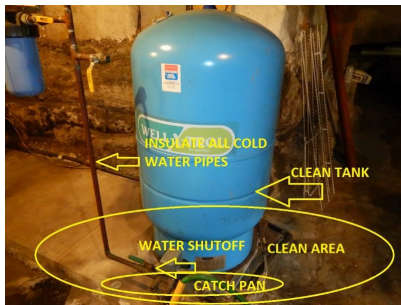
~Well: Pressure Tank, Cleanup, Cold Water Pipe Insulation and Catch-pan: All dirt and debris and any nonessential items should be removed from around the homes water system; The pressure tank needs to be cleaned; Condensation generated from cold water pipes and humid room conditions, common in this area, drip onto floors and drop ceilings if installed; Insulating cold water pipes and adding a drip catch pan below the well pump pressure gauge and piping area at the base of the tank will help lessen this impact.

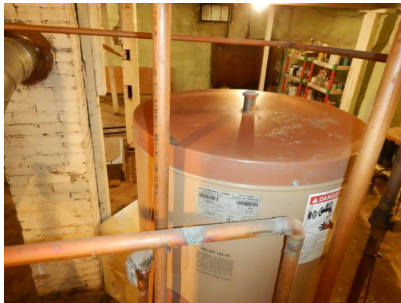
MASTER MIXING VALVE

~Master Mixing Valve: Missing: A Master Mixing Valve, also known as a temperature actuated mixing valve and normally found above the hot water heater was required starting in 2005 for new hot water heater installation; The water heater is missing a temperature actuated mixing valve limiting device installed on water heaters today; Master mixing valve devices are mechanical in nature and help minimize individuals from getting scalded.

~Water Temperature: The end use water temperature measured 140 Degrees; It's generally agreed that 120 degrees Fahrenheit is the maximum safe hot water temperature that should be delivered from a fixture; Therefore hot water above 120 degrees Fahrenheit can be considered hazardous.

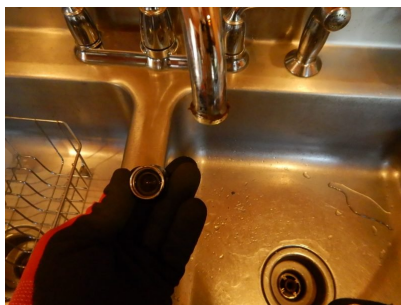
~Clean Sink Aerators and Shower Head Water Ports: To improve general water pressure, cleaning sink aerators of debris and scale and cleaning shower heads of scale will improve water pressure.

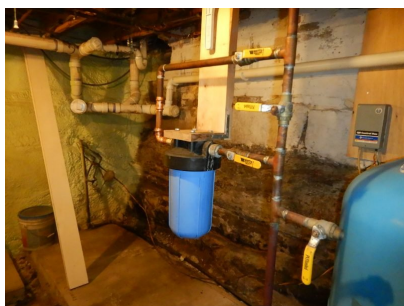
~SED: The home is equipped with a whole house canister sediment filter; The sediment filter cartridge should be changed per manufacturers recommended intervals; If a red or sometimes blue button is present on the top of the filter housing, the button will need to be pressed after closing the water supply to the filter to release pressure.

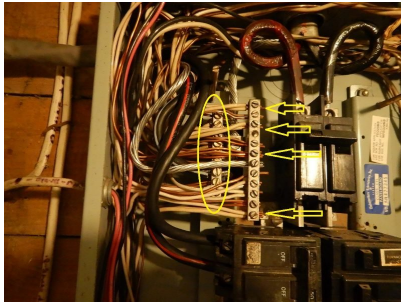
~Excess Ground Wires In One Slot: The number of appliance grounds (copper) in one slot cannot exceed 3; More than 3 grounds in one slot were observed and will need to be separated out.

~Screws: Approved panel screws need to be installed for safety and convenience in reinstalling the panel cover.

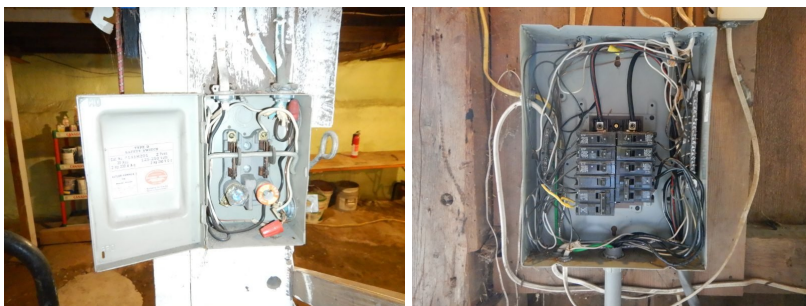
~Inside and Outside Panel Organization: General clean-up, removal and reorganization of excess wiring in and around the panel.

~Double Taps: Double taps or two wires leading into one circuit breaker was observed in the panel; Unless designed for the function, most electrical panels allow only one wire per circuit breaker except for doorbell transformers; Proper panel wiring configurations will need to be completed.

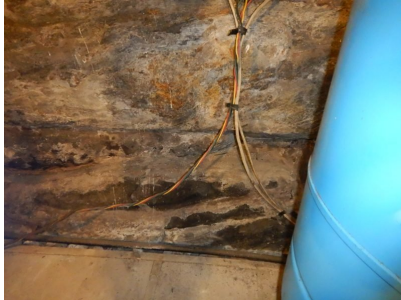
Well Wire

~Extension Cord Use: Extension cords were in use servicing long term appliance equipment in the basement; A plan will need to be implemented with the electrician to install permanent and typed outlets to serve the appliances.

~Basement GFCI's: Unfinished Space: Unfinished basement spaces require GFCI outlets on floor surfaces; Plugs with no GFCI protection were observed in these areas and will need to be corrected.

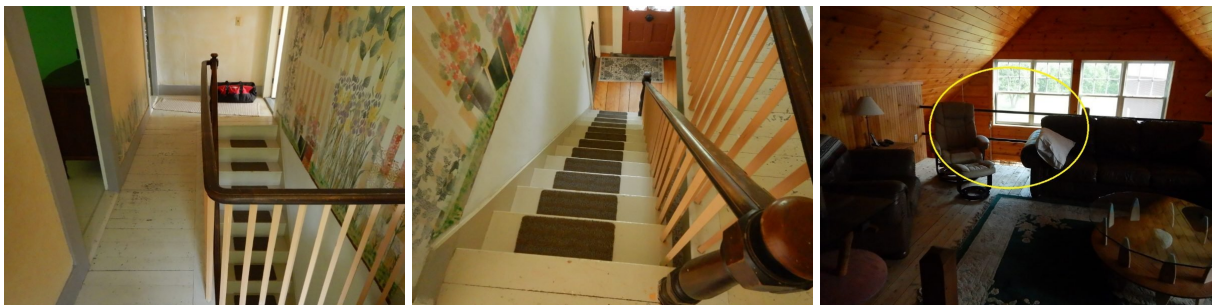
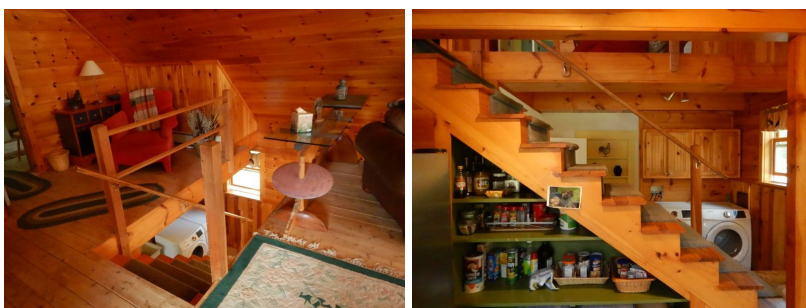
~Rail System: Grasp Rails: Proper grasp rails should be added to the stairs within the home so individuals can safely climb and descend the stairs.

~Stairs: Open Side(s): The stair case opening needs to be properly protected (balusters, panels, cables,etc) to keep individuals from falling from the stairs.

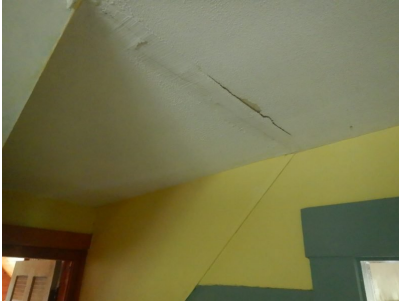
~Loose sheet rock tape was observed in the second floor bathroom; The areas should be taped, plastered and repainted.

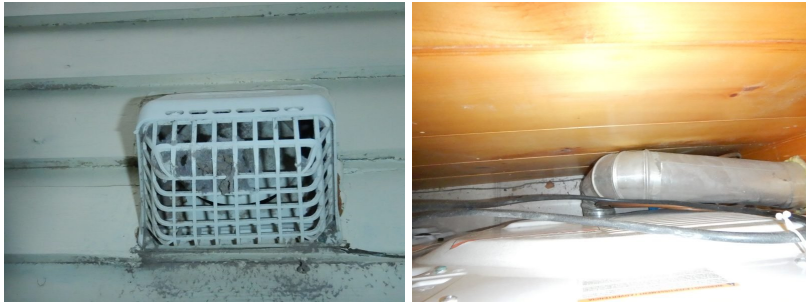
~Important Fire Protection Maintenance: Washer and Dryer Behind and Under Unit Clean-up: As an important maintenance task for fire prevention, the washer and dryer should be removed from their space and the areas behind and under both units cleaned and vacuumed of all lint, dust and objects that find their way behind the units over time; The dryer vent and all connecting venting hoses should be cleaned and if plastic vent pipes discovered replaced with metal and the termination point outside the home confirmed; The clothing washing machine plumbing and drain connections should be reviewed for proper installation and shutoff ability; The clothing washing machine is not tested as part of the inspection due to the possibility of leaving water in the unit; Verification of the units operability should be made with the seller if the unit is part of the sale.

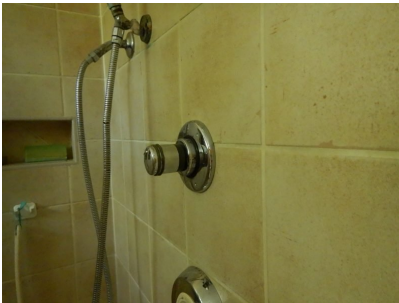
~Shower Control Attached: The shower control is not attached properly and will need to be secured.

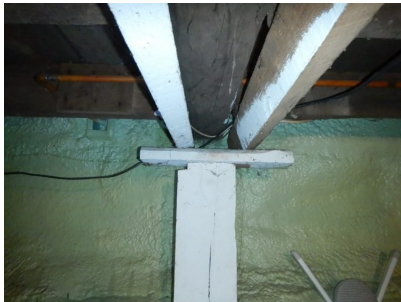
~Support Compression: As a result of an incorrectly blocked floor joists stringers, the stringers have displaced over time as a result of floor load; Options to correct or stabilize the post top and stringers should be explored.

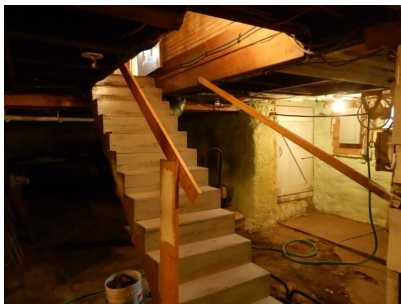
~Antique Stair Construction: The stairs installed to access the basement are under built and should be rebuilt to include proper stair stringers, steps and risers, grasp rails and proper guards on the outside open wall side(s) to protect individuals using the steps.

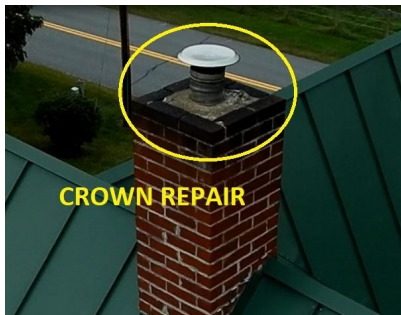
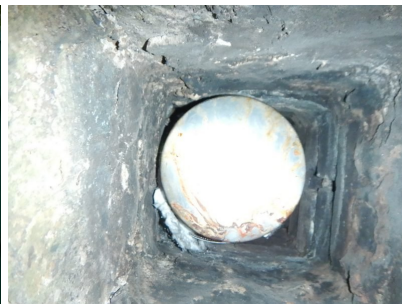
Liner Evidence

~Cleaning and Liner Status and Condition Determination: A common overlooked maintenance item is the chimney inspection and cleaning of the furnace or boiler chimney; Soot, ash, leaf debris and pest activity will build up over the years and wash into the chimney base filling the lower chamber of the chimney and in extreme cases eventually block the exhaust outlet; The chimney should be fully cleaned and brushed and follow-up cleanings scheduled per the maintenance company field recommendations; In some cases the chimney will require the installation or repair of a liner to ensure the safety of the chimney.

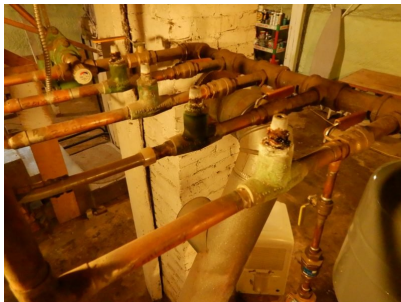
Flow Control Valves

~Leaking Flow Control Valves: A common condition on boilers is leaking flow control valves found on distribution heating lines for the heating system; The control valves needs to be corrected and all rust and corrosion cleaned up; Boiler water is corrosive and if not cleaned will further damage the metal over time. CN.

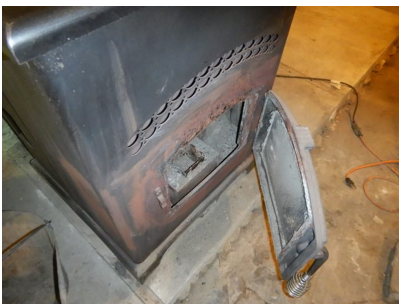
~Pellet Stove/Furnace; Turned Off For The Season: The pellet stove/furnace was not operational at the time of the inspection; Pellet stoves and pellet furnaces are fueled mechanically and as a result it is important to have the unit serviced yearly; Like any heating unit, the pellet stove or furnace and connecting chimney's and flue's should be inspected and cleaned by a processional chimney/fireplace/pellet stove service company before operating the unit; Pellet stoves/furnaces like any heating unit should be serviced and cleaned yearly to ensure full operating and safety requirements.
