# River Valley Home Inspections LLC

# Summary

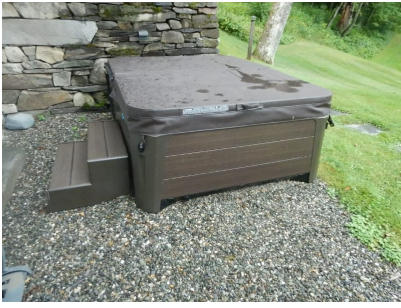
~Active Spa Installed At Home: While not a part of the home inspection protocol, safety features for spa installation has advanced to include specific home and water entrance alarms as well as locking spa covers and other safety features installed to keep individuals from entering spas accidentally when not monitored or in use; It is encouraged to have the spas current safety features reviewed to include all spa electrical grounding systems, current safety features and new advancements in spa safety explored for possible implementation.

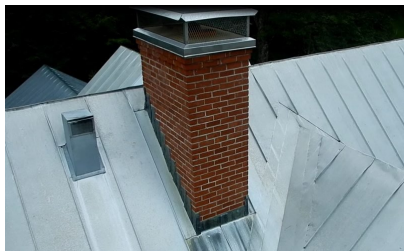
~2020/2021 Winter Season: Brick: Interior Inspection, Cleaning: The brick chimney was observed in satisfactory condition with no visible exterior defects; Visual observation is not enough in the case of chimneys; If not completed for the 2020/21 heating season, a professional chimney service should be consulted for the interior inspection, cleaning and flue condition of the chimney(s) before use; The chimney flashing (metal) and counter flashing will need to be inspected as part of the chimney service to ensure no water is entering the home from this area of the chimney; All service records should be maintained as part of the home file.

~Class 2 Inspection: All Chimneys: Before taking possession of chimneys, a minimum Class 2 Inspection will need to be performed to ensure the interior chimney is in good operating order.

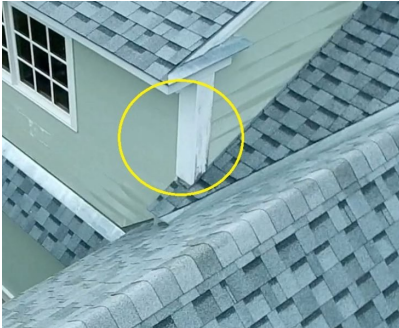
~Interim Paint: Trim: The homes exterior trim is fading in areas of higher moisture contact; To maintain the optimal protection of the homes trim between full paint cycles, the home should be reviewed and touched up in those areas that are fading and peeling; Full painting of the entire surface should be completed on 7 to 10 year cycles dependent on the paints condition.

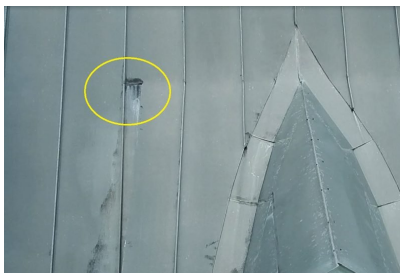
Rear Roof: Open Seam

~Rear of Home: What appears to be a small opened seam with washed sealant was observed on the aerial rear standing seam roof review; The area will require further inspection and if confirmed as opened/aged, the area will need to be repaired to ensure the long term roof weather protection remains intact.

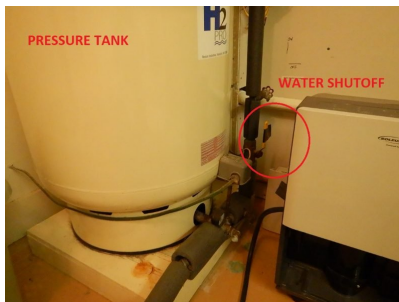
~Well Chatter: As the pressure tank operated, chattering was heard at the pressure tank; In addition, sounding of the tank indicated no reserve of water was stored in the tank; Several causes create this generated sound to include pipe sizing, voltage fluctuations, pressure tank defects, etc; The cause needs to be determined to ensure the well pump and pressure tank system is in good operating order.

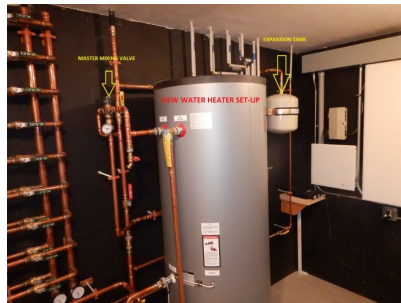
~Master Mixing Valve: Missing: A Master Mixing Valve, also known as a temperature actuated mixing valve and normally found above the hot water heater was required starting in 2005 for new hot water heater installation; The water heater is missing a temperature actuated mixing valve limiting device installed on water heaters today; Master mixing valve devices are mechanical in nature and help minimize individuals from getting scalded.

~Expansion Tank: 2012: Expansion tanks are an important safety feature installed on hot water heaters today allowing hot water to expand and pressure to be relieved on the hot water heater when the tank is heating water.

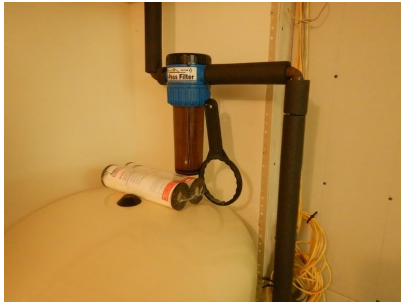
~Sulfur Smell In Garage Bathroom: When running water in the bathroom the smell of sulfur was detected; The sulfur smell may be generated by empty p-traps as a result of the bathroom not being used or is generated by decaying iron bacteria associated with Iron in the water; If still present after filling the p-traps and flushing the water system including the water heater, additional options to include a water softening or carbon absorption system will need to be explored for the home.

~SED: The home is equipped with a whole house canister sediment filter; The sediment filter cartridge should be changed per manufacturers recommended intervals; If a red or sometimes blue button is present on the top of the filter housing, the button will need to be pressed after closing the water supply to the filter to release pressure.

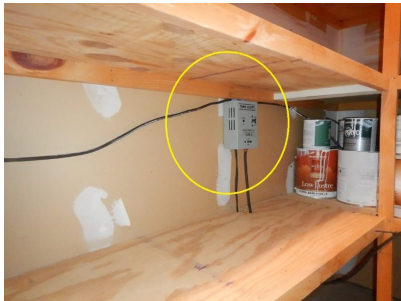
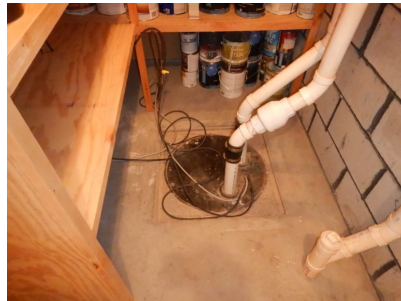
~Pumps: The homes septic system is utilizing an injection or lift pump to assist in the movement of waste water in the system; In these cases, the home is equipped with a septic alarm; The alarm is located below a shelf to the left of the door when entering the utility room; If the the alarm sounds, use of the septic system should be stopped and the septic company contacted; The alarm and all pump systems will be checked during the septic inspection process.

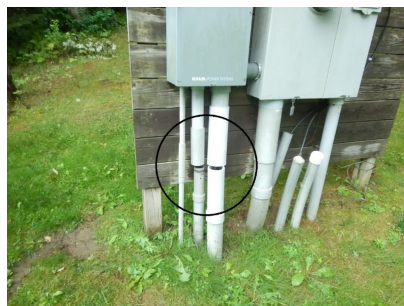
Generator and Home Service Line

~Generator Service Cable Conduit Separation: The conduit protecting the high voltage underground service entrance cables is separated exposing the cable; The conduit needs to be repaired to properly protect the service entrance cable from damage or accidental contact and electrocution; The electric utility company serving the home should be contacted to determine repair responsibility.

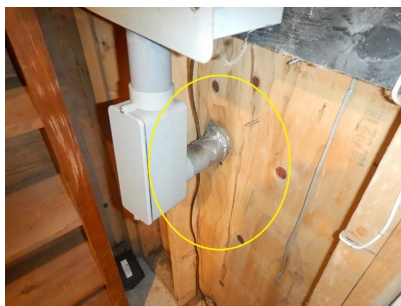
Detached Garage

~Detached Garage Electrical Panel: The separated conduit below the duct tape needs to be properly secured.

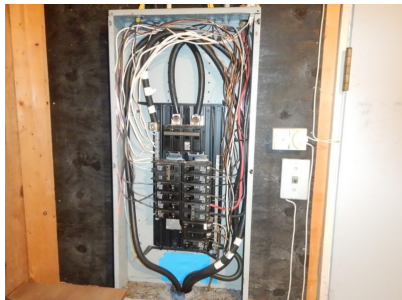
~Several tripped and partially tripped breakers were observed in the garage panel; The panel needs to be fully reviewed and the breakers set/repared to determine the cause of their operation.

~Pest: Mouse Activity: The panel needs to be fully cleaned and all openings sealed; Mice in electrical panels are found electrocuted with collateral damage to the panel wires and circuit breakers.

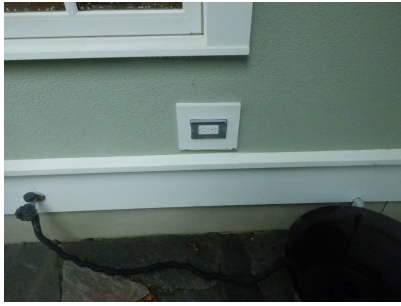
covers; A damaged cover was observed and will need to be corrected.

Missing Exterior Cover

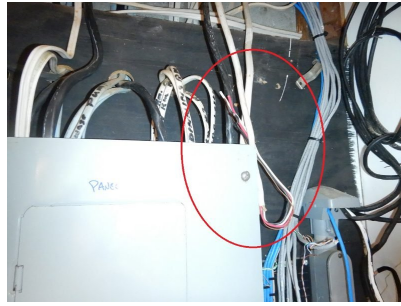
~Improperly Terminated Wire(s): At electric Panel B in the basement; All terminated wires require an approved junction box and cover installed over them to protect individuals and the wire from accidental contact.

Improperly Terminated Wire At Panel

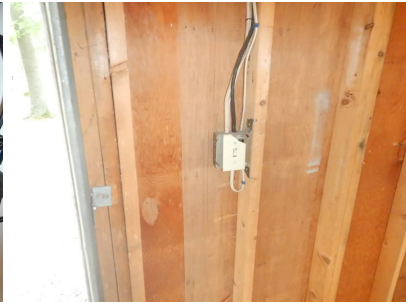
~Full Review: Detached garage : Multiple damaged plug and switch plate covers were observed and need to be repaired.

Damaged Cover In Detached Garage

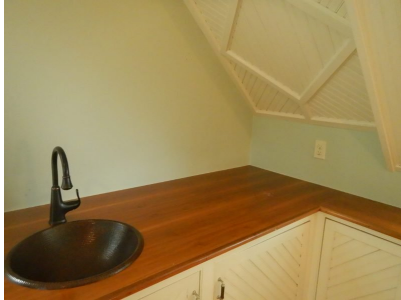
~Catering Kitchen: All receptacles along all counter-top areas greater than 15 inches wide requires and were tested for GFCI protection; The plug along the rear wall counter is not GFCI protected.

Sink Location GFCI Needed

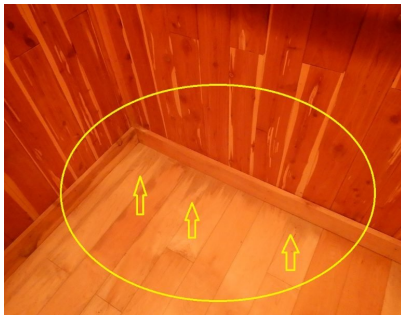
Floor Level

~Basement Cedar Closet: Elevated Moisture Testing: Dark stained floor edges and an elevated level of moisture was identified along the floor and lower walls of the closet indicating moisture seepage into the space between the floor and wall; A more detailed inspection will need to be performed to determine the cause and corrective actions to eliminate the seepage.

~Basement Ceder Closet: Elevated Moisture Testing: Dark stained floor edges and an elevated level of moisture was identified along the floor and lower walls of the closet indicating moisture seepage into the space between the floor and wall; A more detailed inspection will need to be performed to determine the cause and corrective actions to eliminate the seepage.

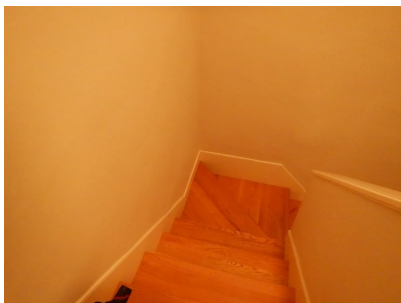
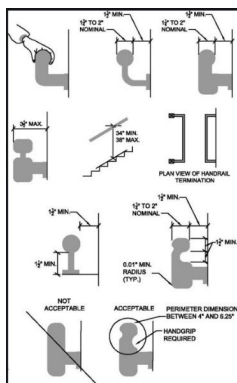
~Grasp Rails Added: All Stairs: Full Length and Unbroken: Flat rail systems found in earlier home designs do not provide proper grasp in the event of a trip or fall on the stairs; Proper grasp hand rail needs to be added to the stairs within the home so individuals can safely climb and descend the stairs; The rail needs to be continuous.

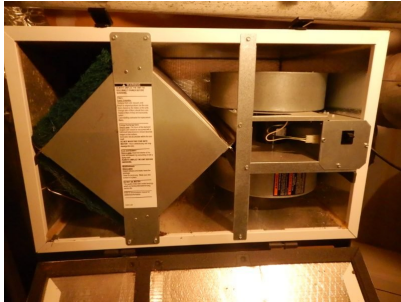
~Energy Recovery Ventilators (ERV's) Installed: 2 Units: Basement and Second Floor Attic Space: Used primarily in cold climates, Energy Recovery ventilators (ERVs) pass two air streams, one into the home from the outside and the other from inside the home to the outside pulling moisture and air impurities through filtration; To ensure optimal performance and air quality, the units should be inspected and maintained per manufacturers cleaning to include washing of filters, vacuuming and wiping down the units interior.

~Timer Units: The current units are on timers; If available for these units, more sophisticated humidity and temperature controls may be considered to optimize the units indoor air improvement functions.

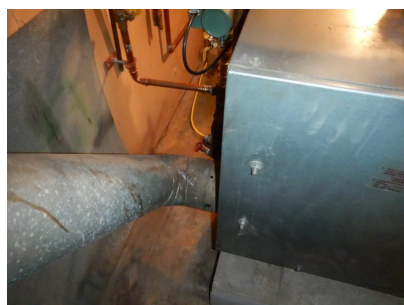
~A Barometric Damper (BD) is missing on the exhaust flue of the boiler; The BD allows for the control of draft conditions increasing efficiency, reducing venting damage and reducing appliance operating problems.

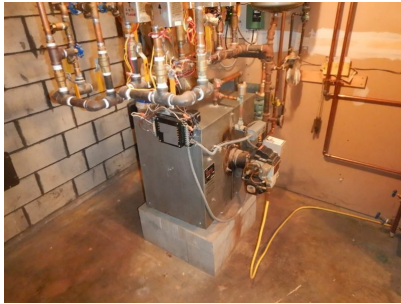
~Boiler Service and Service/Warranty Plans: 2020/21 Heating Season: Last Service Date Tag- 2019: The boiler fired and ran during the inspection process; To set the boilers baseline condition before ownership, it

is recommended a professional heating contractor be consulted to have the boiler serviced and cleaned and/or verification of the recent servicing documented if not completed this year in prep for the 2020/2021 heating season; In addition, the boiler shroud, and all connecting pipes should be cleaned of corrosion and scale and the interior vacuumed and the unit wiped down to eliminate dirt and debris on the boiler surfaces; Oil fired boilers should be serviced every year to ensure the mechanical workings of the boiler are in satisfactory condition; Yearly maintenance service plans and Home Warranty plans including emergency response coverage and cleaning may be available and will contribute to the longevity of existing or new boilers.

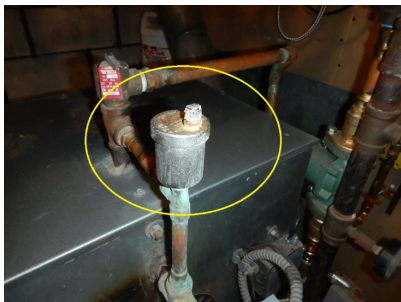
Air Vent

~Leaking Air Vent(s): A common condition on boilers is leaking air vents found above expansion tanks and distribution lines for the boiler; The air vents above the boiler needs to be replaced and all rust and corrosion cleaned up; Boiler water is corrosive and if not cleaned will further damage the metal over time.

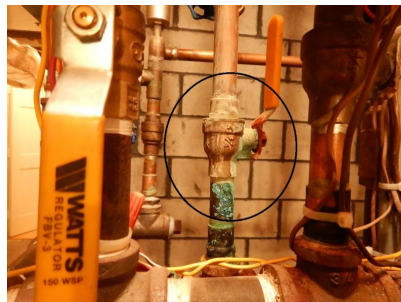
Seeping Valve

~Leaking Shutoff Valve: Seepage: The shutoff valve above the boiler is seeping and needs to be repaired to ensure the seepage does not develop into an active leak.

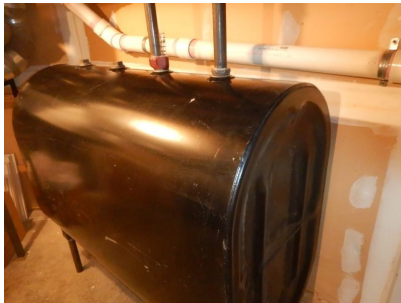
New Hampshire: At Boiler Service Call: While New Hampshire encourages homeowner to monitor the condition of their oil tanks and the tank meets the current standards, it is important to have the oil delivery company verify the tanks condition at the yearly service call.

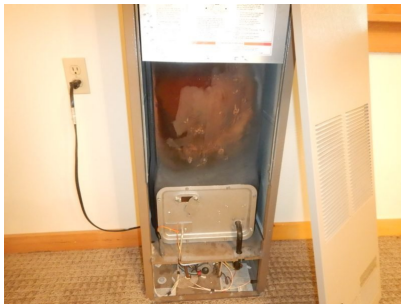
~Empire: Single Unit: The garages primary heating is utilizing an Empire gas unit; The unit's pilot light is burning but the unit would not turn on when the thermostat was activated; A review of the unit will need to be performed to ensure the unit is operational; Like any heating unit, the unit should be vacuumed, cleaned and serviced yearly to ensure the safe operation of the unit including all exhaust mechanicals.

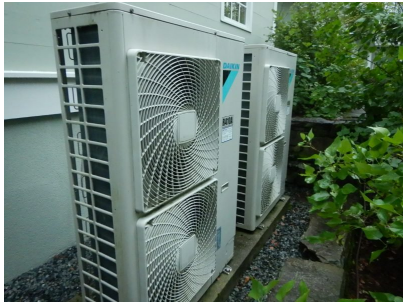
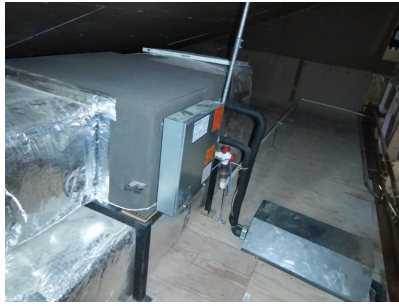
Air Handling Unit

~Air Handlers: All air handlers associated with the air conditioning system located in the second floor bedroom attic space and Master bedroom knee wall access will need to be serviced to ensure they continue in good operating order.

~Full Service: To set the baseline air conditioning performance before taking possession of the unit, the unit will need to be serviced, cleaned and charged to ensure the full operating capacity of the system; Yearly maintenance and service is recommended.

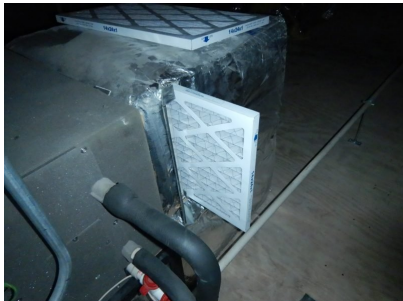
~Air Filters/Handlers: The air handler serving the AC air system needs to be fully cleaned, serviced for operational capacity and all air filters changed and serviced and maintained per manufactures recommendations.

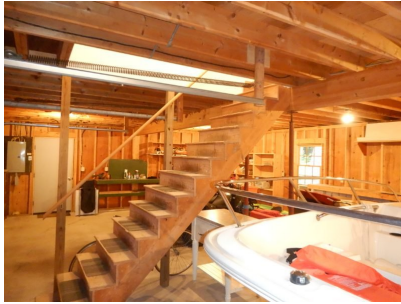
~Guards Added: Guards are missing: All stairs higher than 30 inches from grade require a guard with spacing no more than 4 inches apart (balusters, cables, panels) to help keep individuals falling off the side of the stairs in the event of a trip or fall on the stairs.

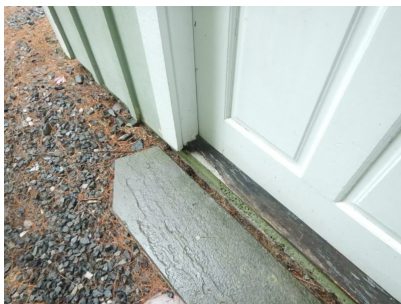
~Door Threshold Damage: The right side door threshold is in decline and will need to be corrected to eliminate further decline of the door base.

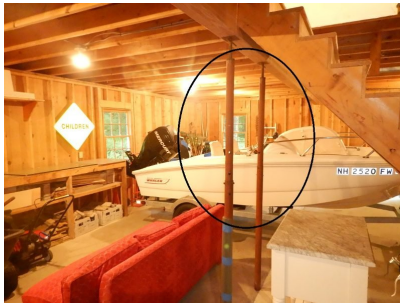
~Temporary Jack Post: Multi Section Temporary jack post were observed in use in the garage; This is a common construction method used in homes and garages and will need to be corrected as temporary jacks fail during fire events; A plan should be created to replace the temporary jack post with the thicker walled single unit metal permanent jack post or wood post approved and properly secured for long term installation.

A permanent support post (can be installed in either orientation)
