River Valley Home Inspections LLC

David M. DeSimone
ID: Board Certified and Licensed in NH and VT
244 Town Shed Road
Orford, NH 03777

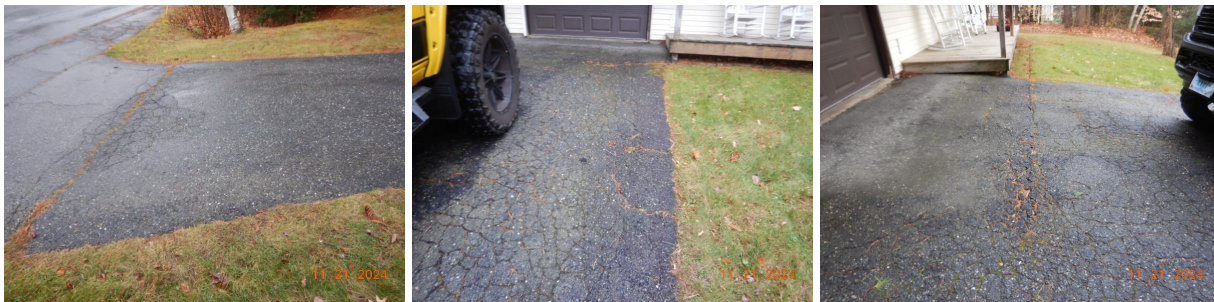
~Asphalt: Age and Settlement: As a result of high moisture content below the drive surface and age, the drive has settled in various areas along the drive surface creating low areas along the drive surface; It is recommended the rive surface be renewed with appropriate stone and drainage to ensure drive remains in good condition; A professional paving contractor will need to be consulted to determine and correct the cause of the settlement.

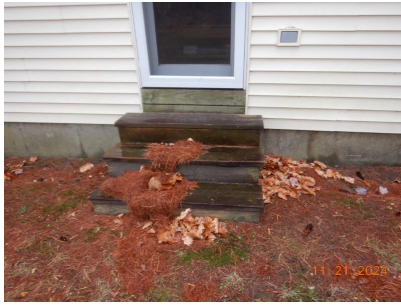
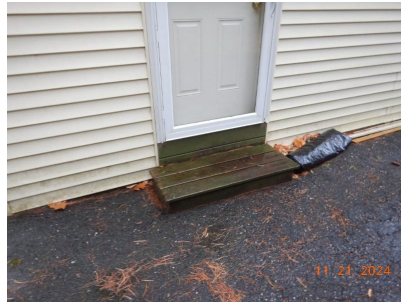
Garage Step.

~Tall Step: Steps Risers Too Tall: The current steps are too tall and exceed the maximum riser height; Steps in this condition may lead to a tripping hazard and will need to be repaired.

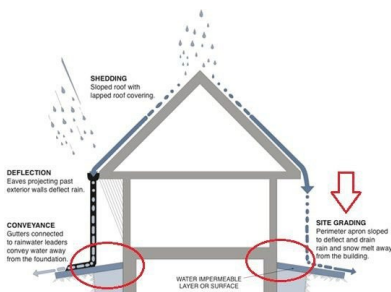
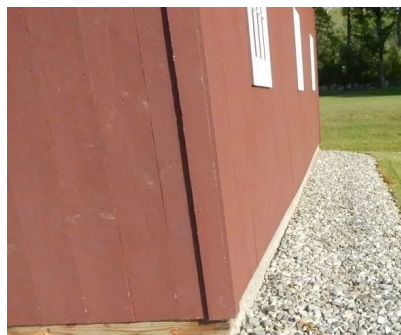
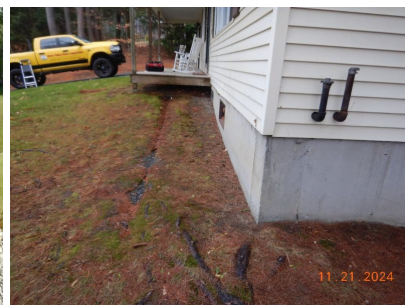
Low Areas: Full Review Of Front, Side and Rear.

~General Grading Needs: The grade along the perimeter of the home is an important factor in keeping moisture away from homes and allowing water to flow away from the home's siding, sills and foundation; A plan should be implemented to upgrade the current grading along the foundation including the walk out door area if present and any planting beds of the home; Grading first with vapor barrier with stone on top should be added to allow water to flow away from the foundation and limit dirt and water splashing onto the siding of the home; The top of the stone border should be at least 6 inches below the edge of the siding when establishing the grade of 5/8th inch pitch per foot fall and/or drained to move water away from the foundation; If unseen decay is discovered in the course of grading improvements, any impacted siding will need to be addressed to include ensuring the sill and wall studs are intact behind the siding.

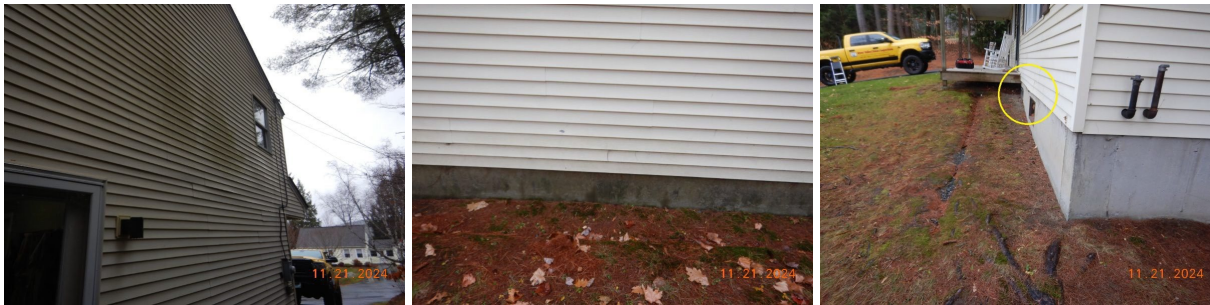
~Vinyl Siding Detached: A lower section of the vinyl siding has detached and will need to be moved back

into place to eliminate gaps in the siding protection; This is an important maintenance item maintains the building envelope against weather and pest infiltration.

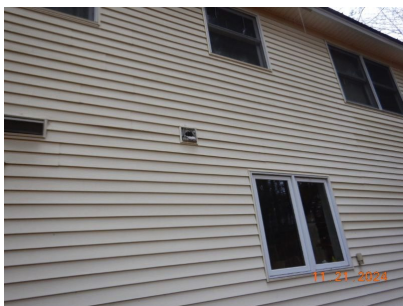
~Dryer Vent Cleaning: The exhaust vent installed on the home needs to be cleaned and all debris removed to allow for the proper operation of the vent.

~Vent Damage: The vent cover on the rear of the home is damaged; To allow air to be directed correctly and keep moisture and pest from entering the home, the vent will need to be replaced.

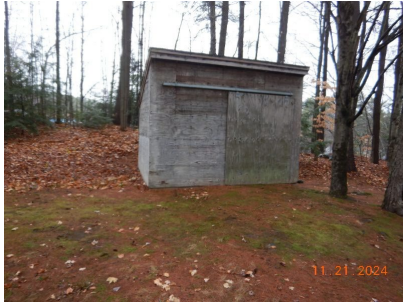
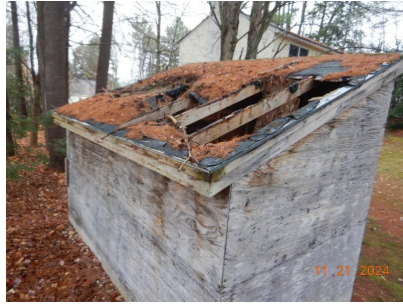
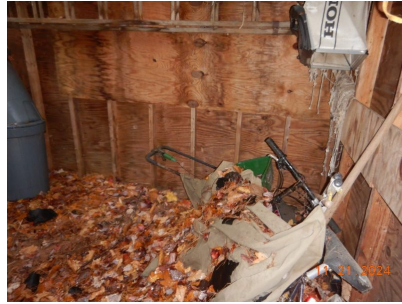
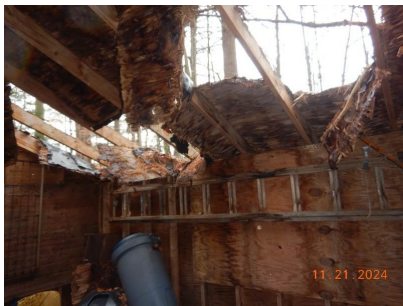
~Roof: The roof is missing; Decay was observed on the roof trusses, sheathing and a large hole has opened on the roof; The damage structure and roof covering needs to be repaired.

~Siding and Trim Decline: As a result of long term weather impacts, the siding, door trim and other parts of the shed are in decline; The areas will need to be reviewed and any decaying or declining sills, wall studs, and sheathing repaired before siding is installed.

~Cost To Repair Versus Replace: A review of the required repair will need to be performed to determine if it

is more cost effective to replace the structure than repair the structure.

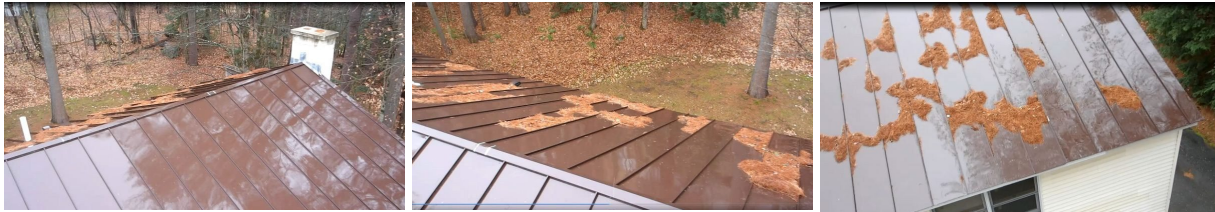
~Cleaning; Seasonal Pine Needles: The pine needles collecting on the roof surface should be removed; Debris like this impedes the flow of water from the roof and creates moist roof surfaces and may damage the roof surface over time.

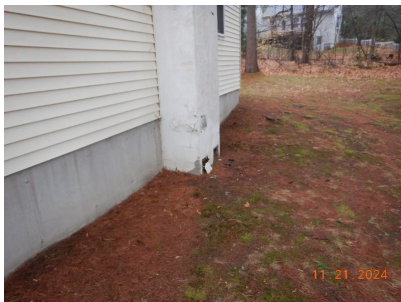
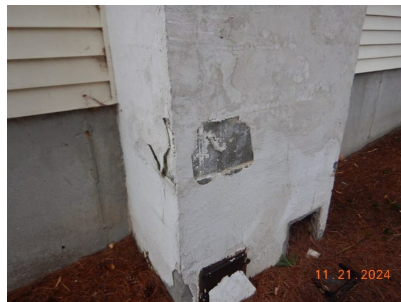
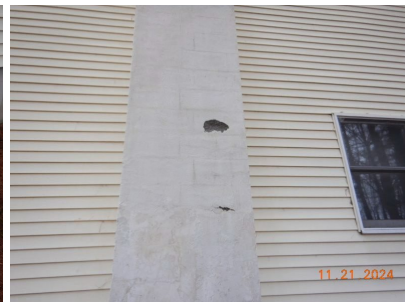
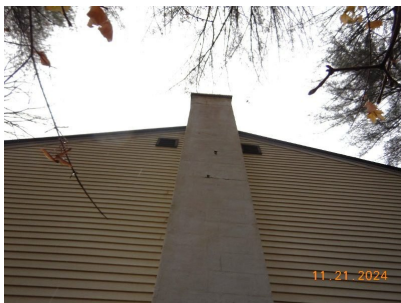
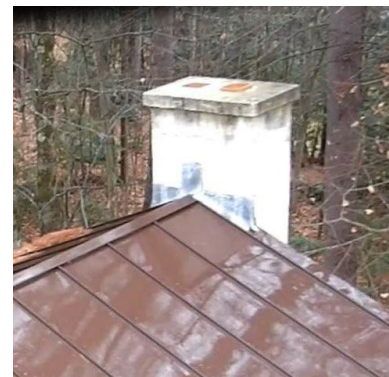
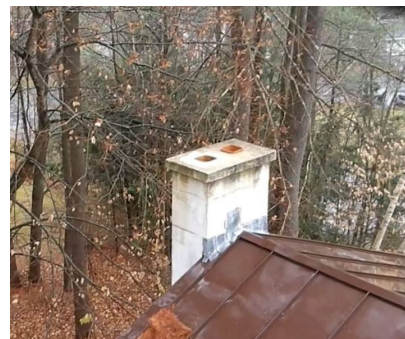
Multiple Areas Of Spalling, Horizontal Joint Cracking Along The Full Chimney To Include Damaged Cleanout Doors.

~2024/2025 Heating Season: Exterior Block, and Crown Inspection, Maintenance, And Repair Needed: The chimney exterior and interior will need to be inspected and signed off as acceptable based on the preliminary observations and repairs completed; Visual observation is not enough and the interior inspection and cleaning of the chimney(s) before use including determining the liner condition and flue configuration will need to be performed; The chimney flashing (metal), counter flashing and crown will need to be inspected as part of the chimney service to ensure no water is entering the home from this area of the chimney; A professional Chimney Sweep will need to be consulted regarding the chimney service.

~Boilers, Furnaces and Gas Heating Appliances: Liner Status and Flue Condition Determination: An important maintenance item is the chimney inspection and cleaning of the furnace or boiler chimney; The chimney will need to be cleaned and fully inspected; In some cases the chimney will require the installation or repair of a liner to ensure the safety of the chimney.

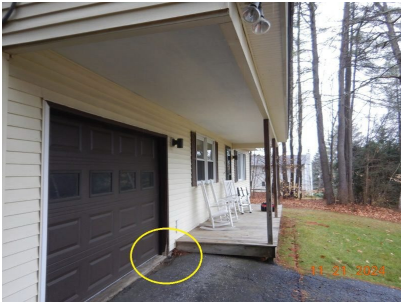
Lower Right Garage Door Trim When Facing The Garage: The lower garage door trim will need to be painted to repair the exposed wood to eliminate future decline of the area.

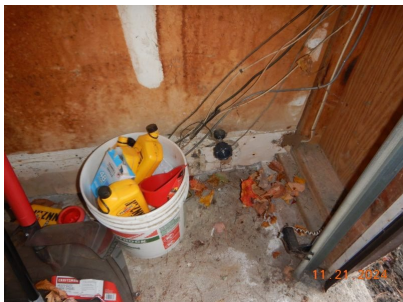
~Moisture Damage At Hose Faucet: Damaged sheetrock was observed at the hose faucet installed in the garage; The cause will need to be determined and corrected to include repair of any structure decay found during the repair.

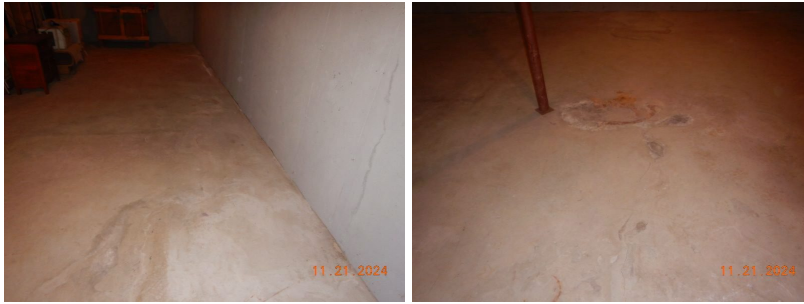
~No Active Moisture, Past Staining, Efflorescence and High Humidity Levels: Current Relative Humidity 67%: The desired state for basement humidity levels is 45% to not greater than 69%; Higher levels of moisture are common in basements not utilizing adequate dehumidification especially in the summer months; While no active moisture was observed in the basement, the use of an enhanced dehumidification system will help improve the general conditions of any basement; Proper exterior grading, cold water pipe insulation, installed dehumidification or an air exchange unit in the basement and proper chimney covers if a chimney is present will aid in eliminating higher levels of humidity commonly found in basements during the summer months and improve air quality of home in general; If more severe water penetration is observed during rainy periods, heavy rain events or winter snow melts, a professional basement water specialist will need to be consulted about potential remedies.

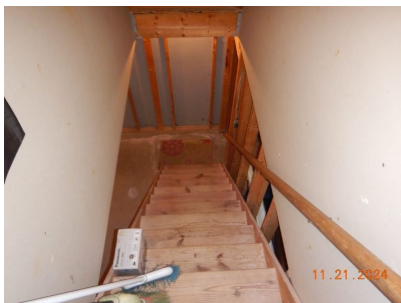
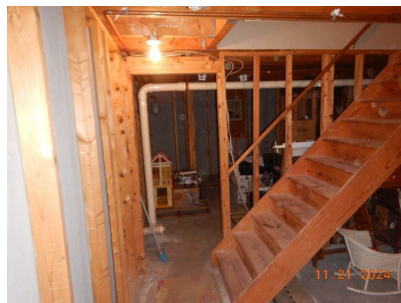
~Grasp Rail Height: Current Rail Height: 30 Inches: Basement stairs require the installation of an approved grasp rail that can be firmly grasp the full length of the stairs at least 34 to 38 inches in height to aid individuals climbing and descending stairs.

~Guards Added: Open Stair Sides: Appropriately spaced guards (balusters no more than a 4 inch sphere passing through, cables, panels or a wall structure) needs to be installed on the open areas leading into the basement along the steps where the steps are more than 30 inches from the floor surface; Guard systems protect individuals from falling through or off the side of stairs in the event of a trip or fall down the stairs.

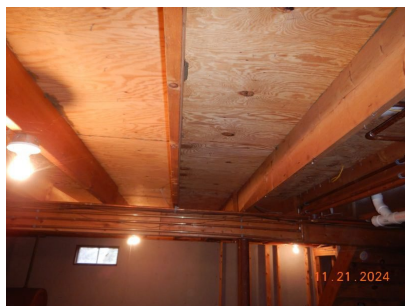
24 Inch Centers And Crippling Evidence

~First Floor Joist On 24 Inch Centers And Missing Blocking: A professional building contractor or Structural Engineer will need to be consulted to determine the best method to enhance the joist strength of the installed floor joist to include the addition of blocking to eliminate the evidence of Crippling along the floor joist.

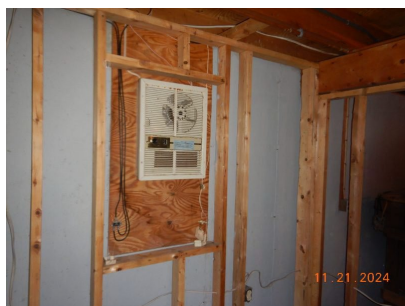
~If Completed: Rough Framed: Second Means Of Egress: All basements with habitable and finished rooms, are required to have an approved secondary means of egress (patio door, walk out Bilco, window, etc.) installed that open out into the yard or open space; The current basement configuration does not meet this requirement.

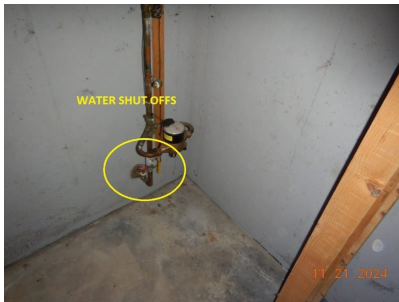
~Public Water: Insulate Cold Water Pipes and Catch Pan: Condensation generated from cold water pipes and humid room conditions, common in this area, contributes to moist basement conditions or drips onto floors and may damage surfaces; Installing a catch pan below the water meter and insulating all cold water pipes will help reduce this condition.

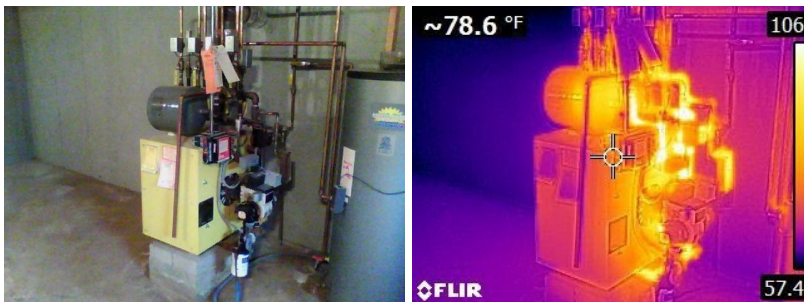
~2024/2025 Heating Season Servicing: Service Plans: Last service date tag-2/23: To set the baseline operating condition of the boiler before taking possession of the equipment, the boiler needs to be fully serviced; It is recommended a professional heating contractor be consulted to have the boilers serviced and fully cleaned; In addition, the boiler shroud, and all connecting pipes should be cleaned of corrosion and scale and the interior vacuumed and the unit wiped down to eliminate dirt and debris on the boiler surfaces; Oil fired boilers should be serviced every year to ensure the exhaust and mechanical workings of the boiler are in a safe and satisfactory operating condition; In many cases, if available for the boiler, home owners will join a service plan or home warranty service to have the boiler protected for emergency repairs and service.

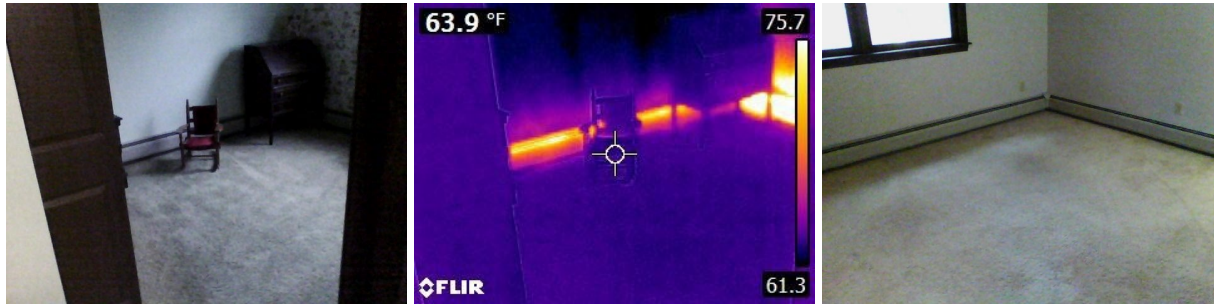
~Pipe Bang At Thermostat Start: A pipe bang was heard when the rear bedroom thermostat was activated: The cause will need to be determined and corrected.

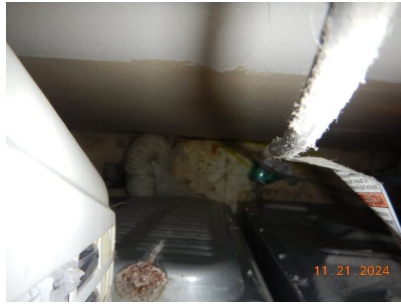
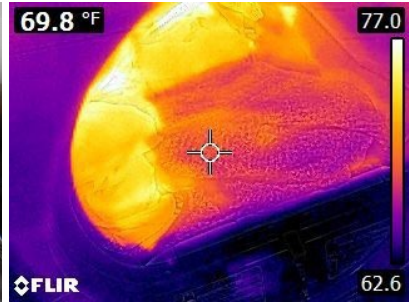
~Important Fire Protection Maintenance: At Purchase and Ongoing: Washer and Dryer Behind and Under Unit Clean-up: As an important maintenance task for fire prevention, the areas behind the washer and dryer cleaned and vacuumed of all lint, dust and objects that find their way behind the units over time; The dryer vent and all connecting venting hoses should be cleaned and if plastic vent pipes discovered replaced with metal and the termination point outside the home confirmed; The clothing washing machine plumbing and drain connections should be reviewed for proper installation and shutoff ability; The clothing washing machine is not tested as part of the inspection due to the possibility of leaving water in the unit; Verification of the units operability should be made with the seller if the unit is part of the sale.

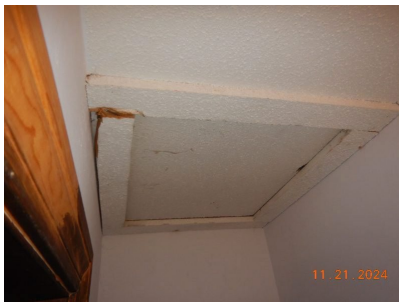
Sealed Access Opening

~The attic opening is nailed and sealed shut.

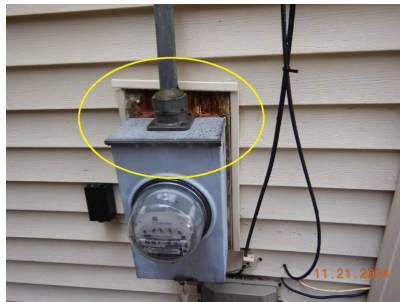
~Renew Meter Panel Support Board: The panel used to support the meter is in decline and will need to be renewed to ensure the meter panel remains intact over time.

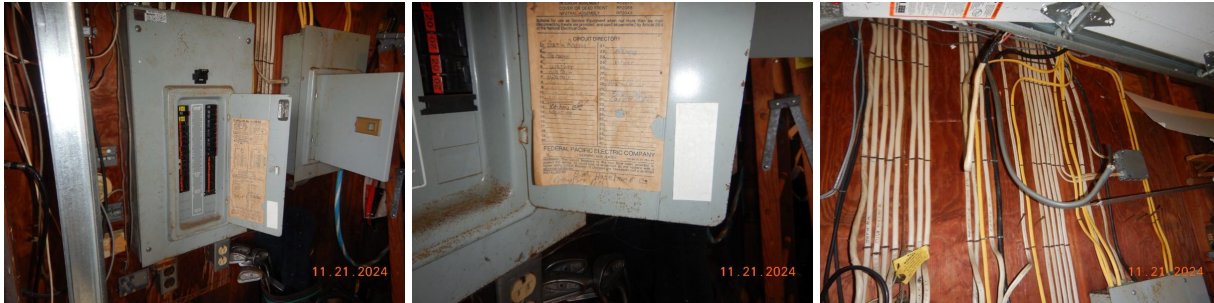
~Federal Pacific Electric Company: Panel The home's main electric panel and circuit breakers are referred to as the "Stab-Lok" type manufactured by the Federal Pacific Electric Company; Federal Pacific electrical devices of this type are prone to higher electrical failure rates and subsequent fire risk associated with those failures and it is recommended the panel be replaced; As a result of the panel design requiring the circuit breakers to be turned off, the panel cover was not removed: A full review of the wiring connection points, type, and grounding requirements will need to be performed at the panel replacement.

~Improperly Terminated Wires: Outside The Panel: The terminated wires need to be properly installed in a closed junction box or removed.

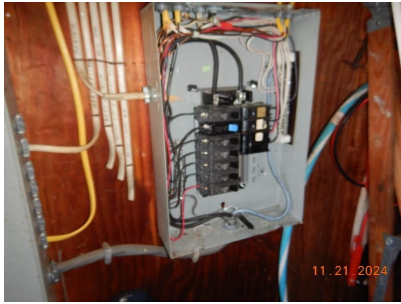
~Labeling Baseline Reset: The panels labeling needs to be updated to confirm or correct the labeling to match current use areas of the home.

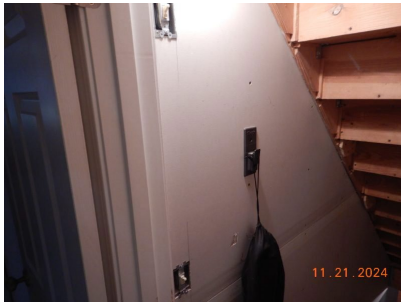
~Open Junction Boxes: Basement Wall: An open junction box(s) was observed and needs to be properly covered.

~Missing cover plates on electrical junction boxes were observed in the basement.
