River Valley Home Inspections LLC

David M. DeSimone
ID: Board Certified and Licensed in NH and VT
244 Town Shed Road
Orford, NH 03777

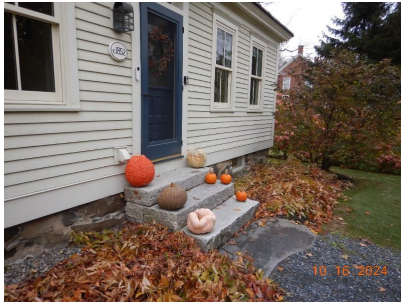
~Landing Needed: Primary Front Entrance: The front entrance leading to the home needs to be reconstructed; The steps require a properly sized landing (36 inches deep in the direction of travel into the home) at the top and bottom of the steps allowing individuals to safely enter and exit the home.

~Stairs Less Than 30 Inches From Grade: Stairs into homes with 4 or more risers and less than 30 inches from grade requires a graspable rail on one side of the stairs; A professional building contractor should be consulted about the various options to make the stairs safe.

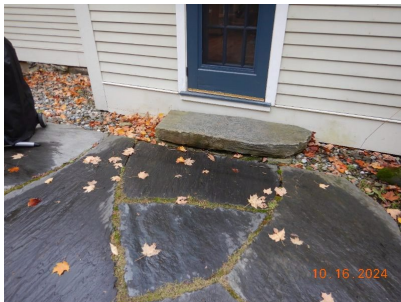
Rear Step From Center Garage Onto The Patio.

~Stone Step Settlement: Leaning: As a result of the weight, time and soil settlement over the years, the stone step has settled; A condition caused by a lack of a properly installed sub base to support the steps, the step needs to be lifted to allow for properly leveled step surfaces, proper drainage away from the home and safe step surfaces for climbing and descending the stairs.

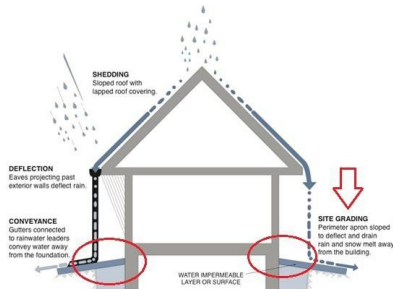
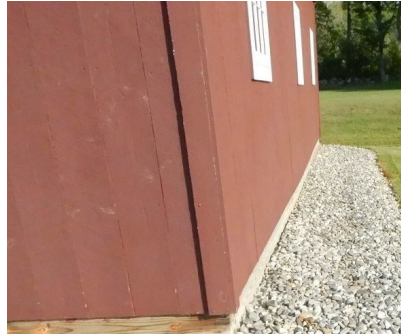
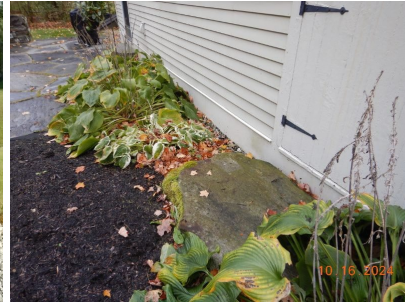
Garage Portion Of The Home Too High.

~Ongoing General Grading Needs: The grade along the perimeter of the home is an important factor in keeping moisture away from homes and allowing water to flow away from the home's siding, sills and foundation; A plan should be implemented to upgrade the current grading along the foundation including the walk out door area if present and any planting beds of the home; Grading first with vapor barrier with stone on top should be added to allow water to flow away from the foundation and limit dirt and water splashing onto the siding of the home; The top of the stone border should be at least 6 inches below the edge of the siding when establishing the grade of 5/8th inch pitch per foot fall and/or drained to move water away from the foundation; If unseen decay is discovered in the course of grading improvements, any impacted siding will need to be addressed to include ensuring the sill and wall studs are intact behind the siding.

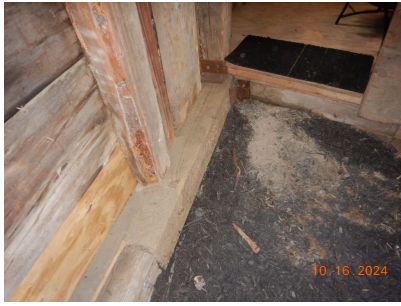
Garage.

~Sill On Soil Contact and Twisted New lapped Sill Section: As a result of the displaced foundation and old building construction methods, the sill is contacting the soil along parts of the sill; After the grade is lowered, a full review of the sill will need to be performed to ensure the unobserved areas of the sill are in good condition and the foundation below the sill is secured.

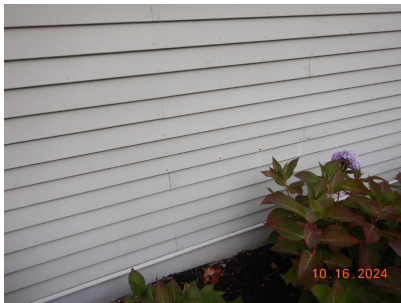
~Full Painting: The home's exterior siding is nearing the end of a paint cycle; To maintain the optimal protection of the homes siding, the home should be painted; Painting should be completed on 7 to 10 year cycles dependent on the paints condition with yearly touch-ups where needed between full painting cycles; Prior to painting, the home should be fully reviewed and any damaged siding discovered in the review should be repaired to eliminate further decline of the remaining siding as well as protecting the structure behind the siding from further damage due to water penetration; Please note: the wall sheathing, 2X4 wall studs and sill behind the siding should be checked for damage when the siding is removed and repaired in these areas if damage is identified.

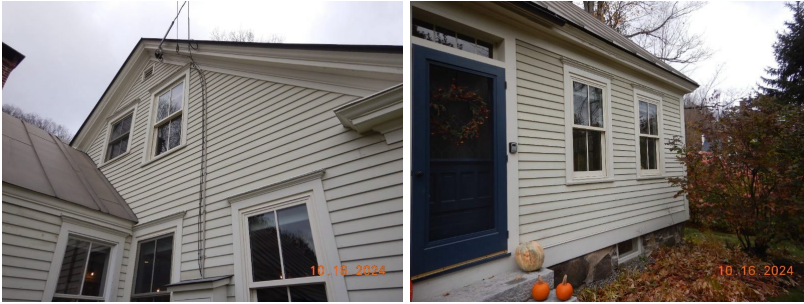
~Full Painting: The homes exterior eaves and soffits are at the end of life and paint cycle; To maintain the optimal protection of the homes trim, eaves and soffits, the home should be re-painted; Painting should be completed on 7 to 10 year cycles dependent on the paints condition with yearly touch-ups where needed between full painting cycles; In preparation for the painting, all of the wood surfaces will need to be scraped

and any decayed or declining wood repaired prior to painting.

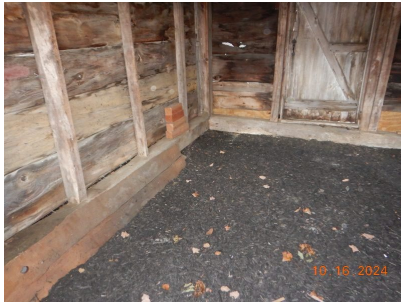
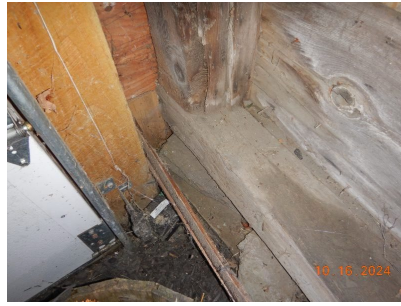
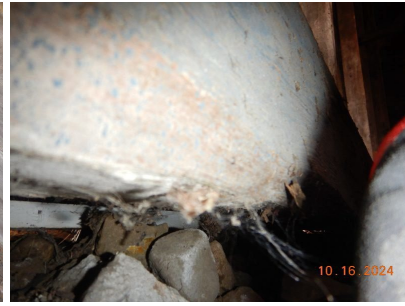
Garage.

~Stone Foundation Displacement: The garage/barn stone foundation has gaps and openings that need to be filled, stones re-stacked and secured to allow for properly supporting/protecting the sill of the garage over time and limiting pest and moisture incursion into the space below the garage; Options to correct the foundation will need to be performed.

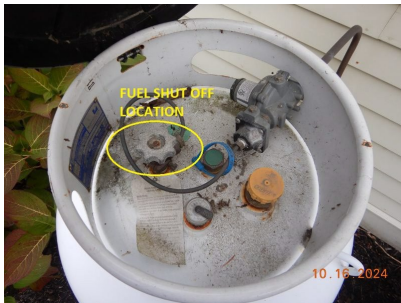
~Propane Tank, Piping and Regulator(s): The propane delivery company will need to be contacted to confirm the propane tank ownership and condition, corrugated stainless steel tubing (CSST) pipe bonding if applicable, meter condition if applicable, and the condition of the interior and exterior lines, shutoffs and regulators serving the home before taking ownership of the system.

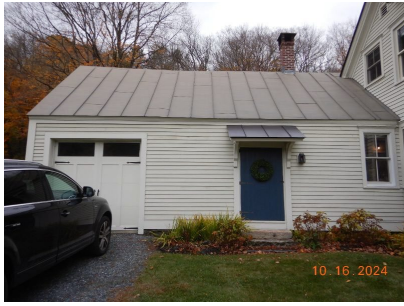
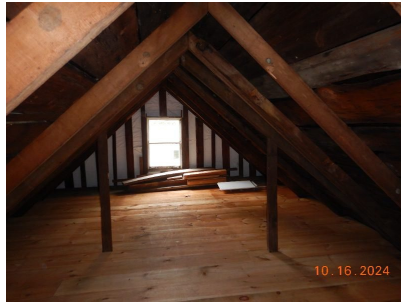
~Antique Home Ridgeline Sagging: A sagging ridge line was observed along the roof; While the roof covering is intact, several factors may contribute to this observation to include poor transition points between old and new construction periods, post and beam settlement, undersized/spaced roof rafters, foundation settlement and other factors; Professional building contractors are available to determine and correct the cause.

~Dips In Center Roof Line Surfaces: Dips were observed along the rear center roof surfaces; Caused by long roof rafter spans in antique home construction, the roof surface, pitch and interior attic structure is intact; Methods to reinforce the long spans are available within the attic space; A professional building contractor will need to be consulted regarding the additional reinforcement if desired.

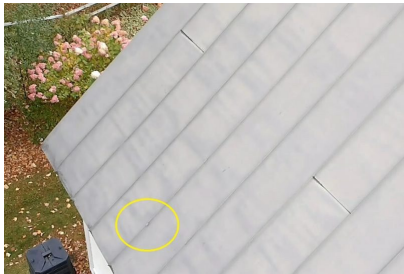
Rear Of Home.

~Tab Maintenance: The tie tabs used to secure the standing seam panels together have moved or dislodged; Common on roofs this age as a result of snow and ice sliding over the years, the roof will need to be reviewed, and all tabs secured; Loose tabs may lead to roof panel lifting in heavy winds.

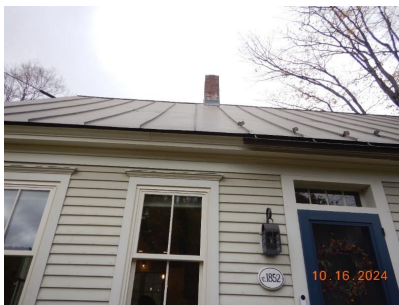
~To aid in draining roof water runoff from around the home and foundation, additional gutters may be considered; Gutter type, size and strength is important in this geographic area; Gutters, downspouts and extensions need to withstand snow and ice sliding from roof surfaces and have the ability to catch and carry large amounts of water as a result of steep roof pitches.

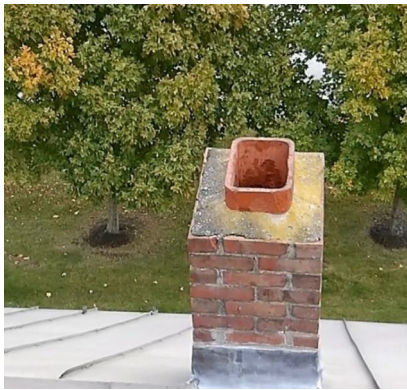
~2024/2025 Heating Season: All Chimneys: Brick and Crown Maintenance Needed, Cleaning, Surfaces Sealed, Caps and Flue Liner Condition/Determination: The chimney exterior will need to be inspected, cleaned and repaired if required to eliminate brick and crown damage over time; Visual observation is not enough in the case of chimneys and a professional chimney service should be consulted for the interior inspection and cleaning of the chimney (s) before use if not completed this year including determining the liner condition and flue configuration; The chimney flashing (metal), counter flashing and crown will need to be inspected as part of the chimney service to ensure no water is entering the home from this area of the chimney; In addition to the inspection and cleaning of the chimney, weather caps should be installed on all chimney openings to eliminate any moisture from entering the chimney opening if not installed or if the existing covers are damaged.

~Boilers, Furnaces and Gas Heating Appliances: Liner Status and Flue Condition Determination: A common overlooked maintenance item is the chimney inspection and cleaning of the furnace or boiler chimney; The chimney will need to be cleaned and fully inspected; In some cases the chimney will require the installation or repair of a liner to ensure the safety of the chimney.

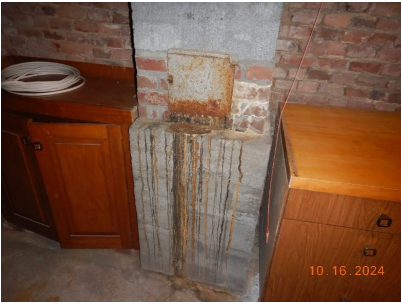
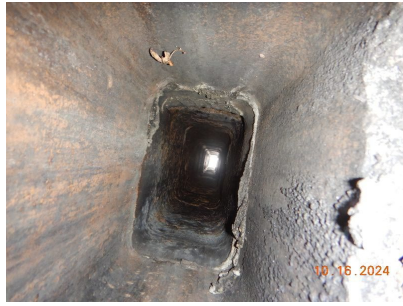
Garage Side Chimney.

~Moisture Stains At Base: Moisture staining at the base of the interior chimney indicates prior staining, moisture is entering the top of the chimney, or condensation is being created within the chimney from the wood stove operation; At the chimney inspection and service, the cause will need to be determined.

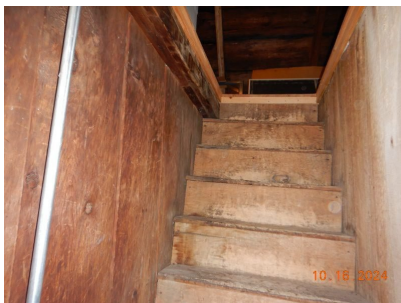
~Open Attic Second Floor Storage Floor Areas and Stairwells: Guards: Balusters: Open areas above stairs and along walls need to be properly protected with guards installed to include balusters or cables spaced, spaced no more than 4 inches or a panel to keep individuals and pets from falling or backing off into the stairway or floor area.

~Steep Stair: Tall risers and short runs are creating a steep stair. Options to correct the observation will need to be explored.

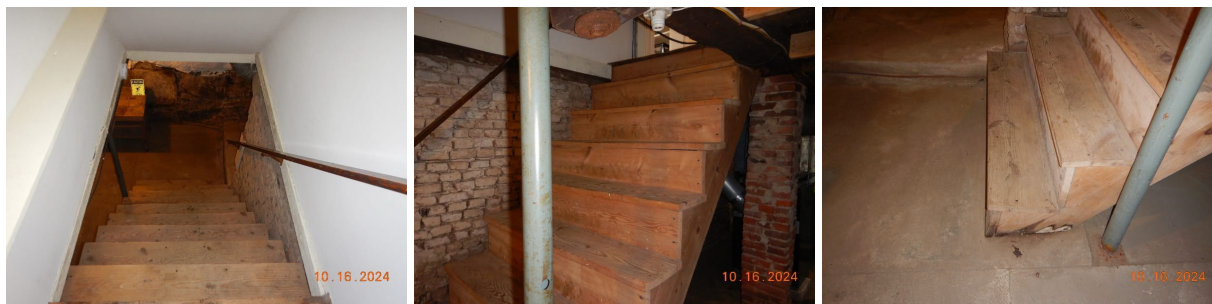
~Head Room: The current stair does not meet headroom clearance specifications of 6'8"; If not corrected care should be taken when using the stairs.

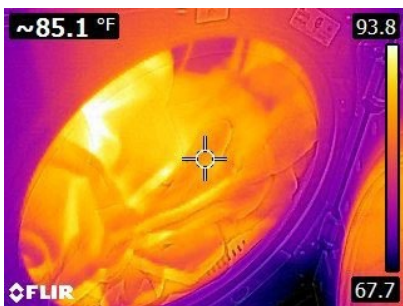
~Important Fire Protection Maintenance: Washer and Dryer Behind and Under Unit Clean-up: As an important maintenance task for fire prevention, the areas behind the washer and dryer cleaned and vacuumed of all lint, dust and objects that find their way behind the units over time; The dryer vent and all connecting venting hoses should be cleaned and if plastic vent pipes discovered replaced with metal and the termination point outside the home confirmed; The clothing washing machine plumbing and drain connections should be reviewed for proper installation and shut off ability; The clothing washing machine is not tested as part of the inspection due to the possibility of leaving water in the unit; Verification of the units operability should be made with the seller if the unit is part of the sale.

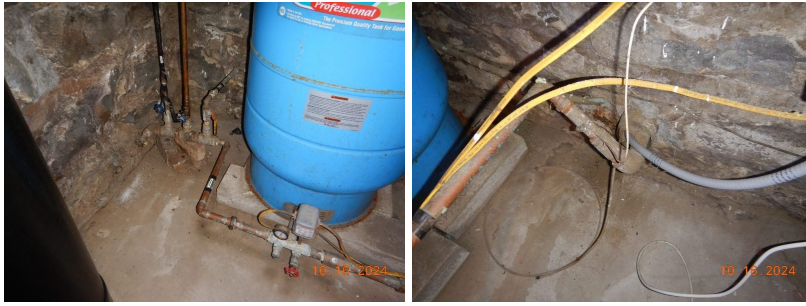
~Galvanized Piping and Fittings: Water Flow Impacts Over Time: Galvanized pipe was observed where the water line enters the home; Galvanized pipe rust from the pipe's interior may distribute rust particles into the water system over time restricting water flow into the home and eventually plugging the line; Option to replace the line will need to be explored when the line reaches its end of life or rust particles are found in the water.

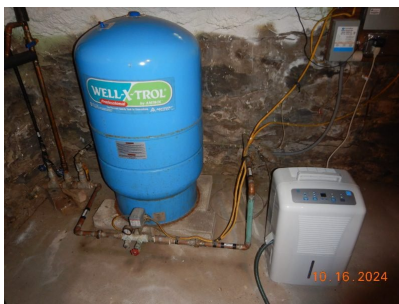
~Well: Pressure Tank, Cleanup, Cold Water Pipe Insulation and Catch-pan: If not in completed, all dirt and debris and any nonessential items should be removed from around the homes water system; The pressure tank area needs to be cleaned; Condensation generated from cold water pipes and humid room conditions, common in this area, drip onto floors and drop ceilings if installed; Insulating cold water pipes and adding a drip catch pan below the well pump pressure gauge and piping area at the base of the tank will help lessen this impact.

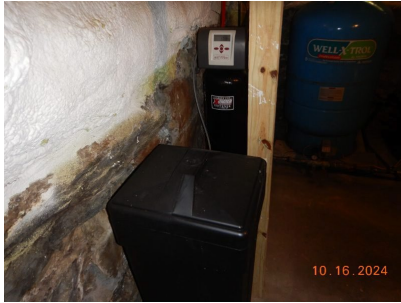
~Water Softener Well Application: Full Surface Cleaning and Service: The home is equipped with a whole house water conditioning / softening system; The water conditioning unit should be cleaned and serviced to establish the baseline operating verification and serviced on a yearly basis going forward to ensure the system is operating correctly.

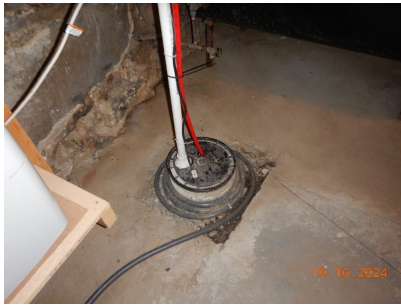
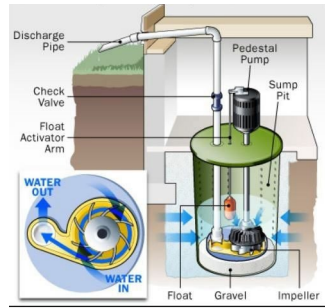
~Septic/Municipal Discharge: The sump pump is connected to the waste removal system: Options to properly drain the sump pump to the exterior of the home will need to be explored to eliminate additional water flow into the waste removal system.

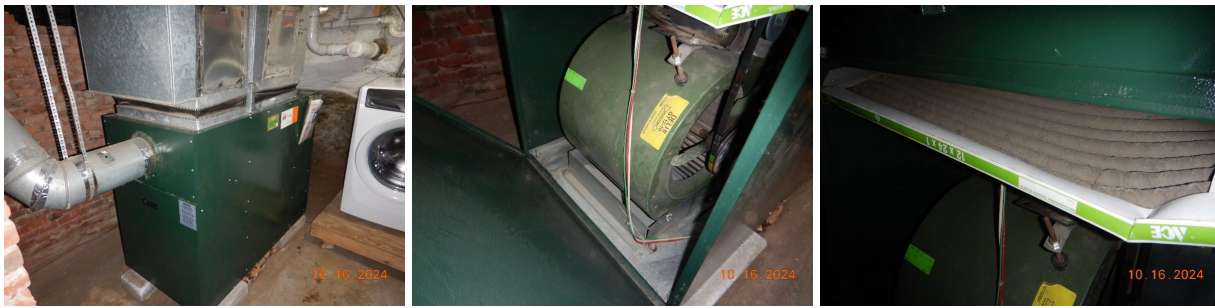
~Dirty Filter: Fan Housing Cleaning and Air Filter: Electric power to the unit will need to be turned off before any work is completed in the filter compartment of the heater; Air filters should be changed/cleaned per manufacturers suggested periods to ensure proper air flow and air filtration in the home; The full space and all fan components should be cleaned and vacuumed to remove debris; Companies that will clean the duct work of dust and danger and debris accumulated over the years in the duct work are available.

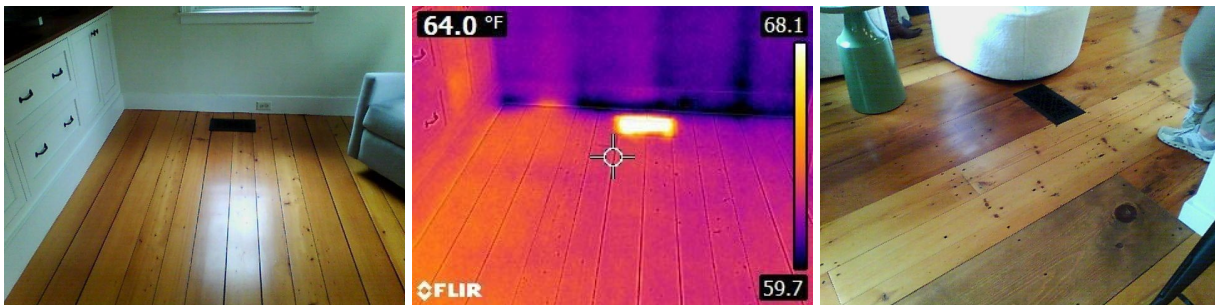
~First Floor Heat and Limited Second Floor (Heat Rising): The home's heating distribution system primary heat source is the first floor only; This observation is found in older homes in this area; It is recommended a professional heating contractor be consulted to explore the possibility of extending the current heating distribution system or adding supplemental heating units to the second floor rooms and baths as extremely cold winter conditions may impact living and plumbing functions in these areas if heat in these areas is not adequate.

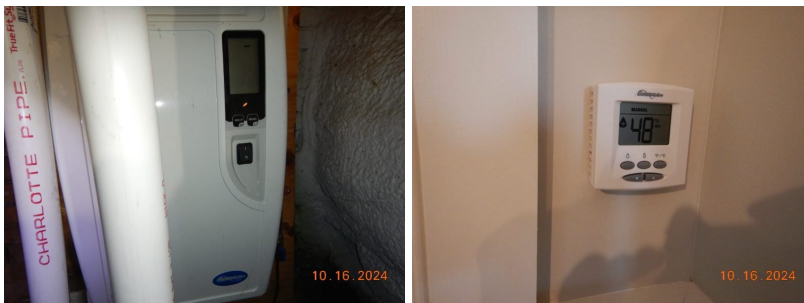
~A humidifier unit was observed on the heating unit; A full service will need to be performed to ensure the unit is operational to include cleaning and other maintenance needs per manufactures recommendations to ensure the unit remains in full operating capacity.

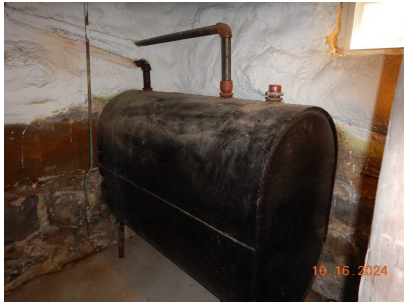
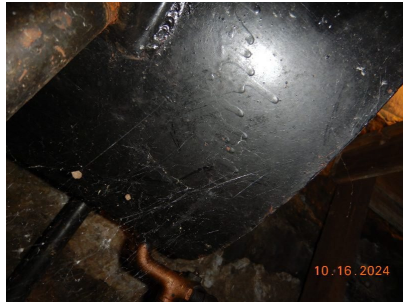
~Vermont: At Equipment Service: Oil Delivery Company 2017 Tank and Fuel Line Verification and Sign Off: The existing tank is in operational condition but proof of the 3 year inspection requirement was not verified; 2017 oil tank inspection and regulatory requirements require the oil company to inspect the tank every 3 years; The oil delivery company should be contacted to have the tank inspected and signed off as acceptable for fuel oil delivery before taking possession of the tank; In some cases, components of the tank or the whole tank are required to be replaced.

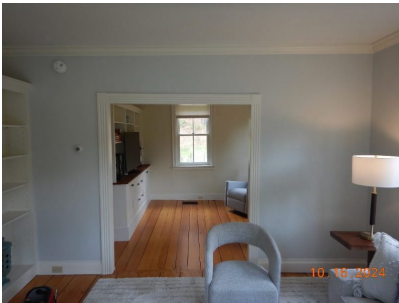
Racked Door Frame As A Result Of
Floor Deflection

~Uneven Floor Areas: Antique Homes: This condition is common for home this age and if corrected will create significant repair needs to existing walls and trim; If the floors are leveled through jacking of basement and first floor ceiling beams, the work should be completed before the upper floors' renovation work; Alternate options to include floor removal and leveling may be utilized to correct the condition; Professional building contractors are available to assess the floors if desired.

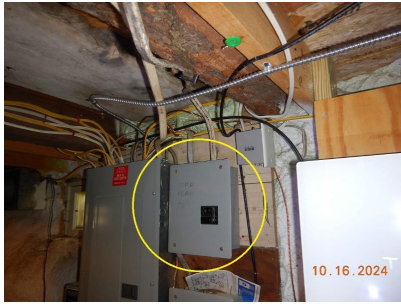
~Electrical Rate (ER) Meter Indication: Labeling in the basement sub-panel indicates the home's hot water heater is equipped with an ER meter: ER meters were installed for many electric applications including heat and water heaters providing reduced electric rates for off peak usage; The utility serving the home should be contacted when the account is set up to inquire if the rate, functions and operating parameters are available for use.

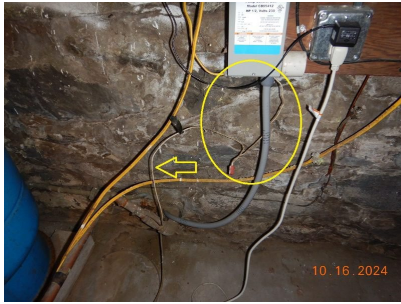
~White Wire From Pump Control: The white wire installed from inside the pump control box and attached to the water line needs to be inspected by a licensed electrician to determine its use, installation and safety.
