River Valley Home Inspections LLC

David M. DeSimone
ID: Board Certified and Licensed in NH and VT
244 Town Shed Road
Orford, NH 03777

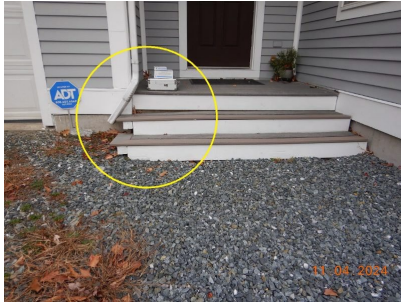
~Landing Pad Added: An important addition at the bottom of a steps or stairs from a home is the addition of a landing pad; Landing pads allow for the safe stepping into or out of homes or onto and off stairs.

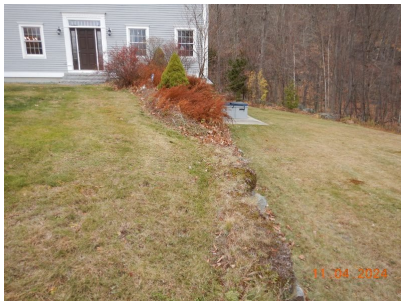
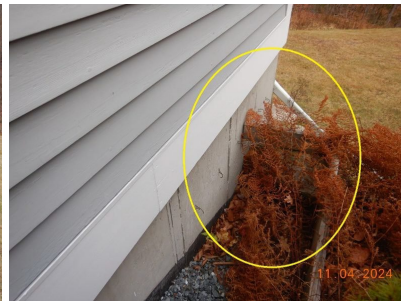
~Erosion: As a result of slipped stones, the soil at the top of the wall has eroded; The stone wall will need to be reestablished, and the area filled and graded along the home to eliminate the observation.

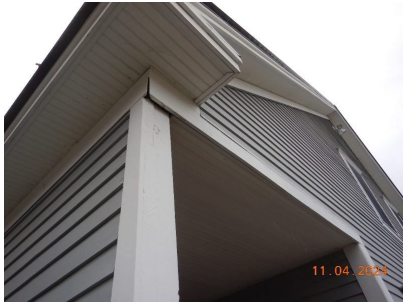
~Soffit and Fascia Board: Gaps: Gaps along the fascia boards were observed along the corner of the soffit; After the cause is determined and corrected, the area will need to be sealed including filling and finishing any gaps.

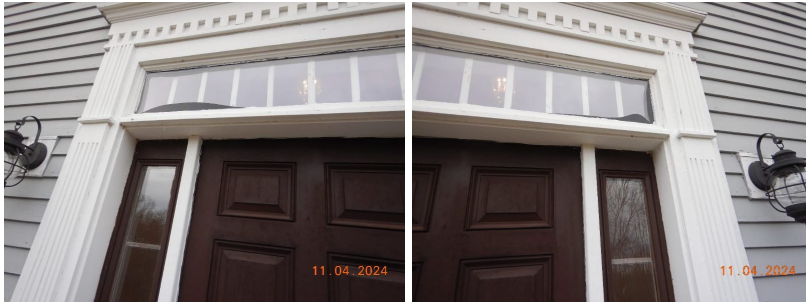
~Front Transom Window Above Front Door: As a result of heat buildup, the seal installed between the window panes has deformed and moved into the window space; A professional window company will need to be consulted to correct the observation.

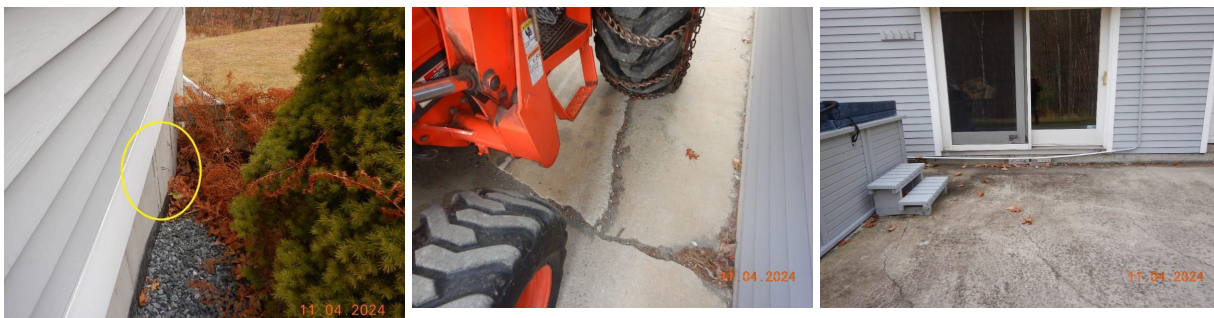
~Cracked and settled slabs were observed; The cause will need to be determined, and the areas corrected to eliminate the observation.

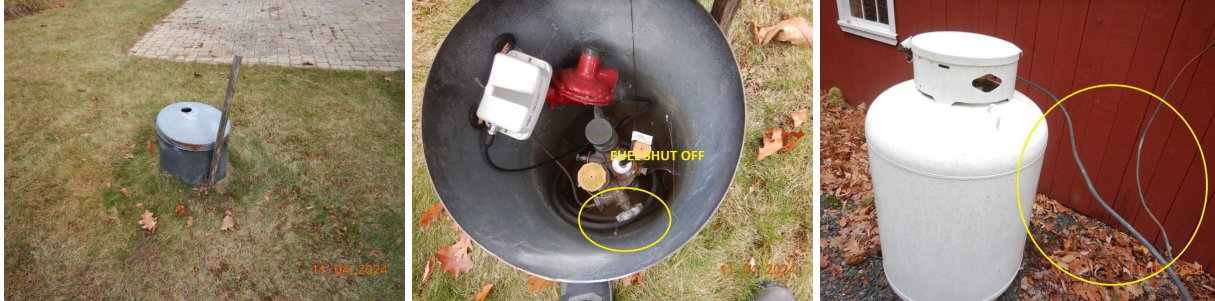
The floating fuel line needs to be properly secured.

Improperly Secured Full Line

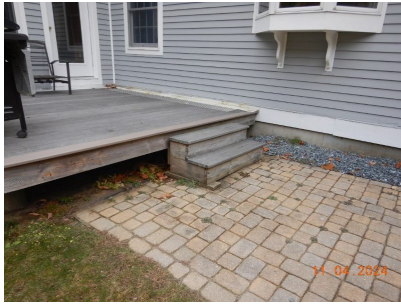
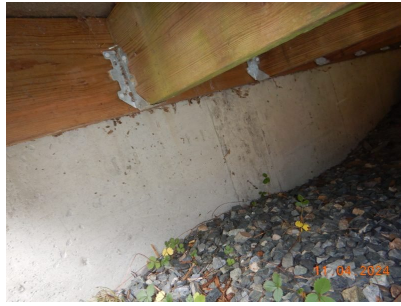
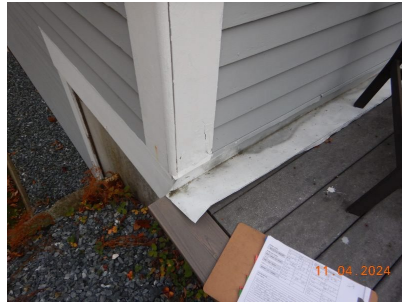
~Improperly Flashed: The displaced flashing needs to be properly installed.

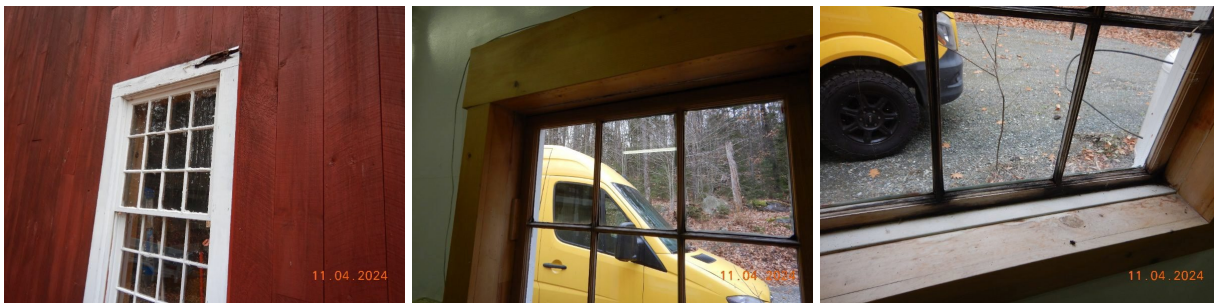
~Decay Observed: As a result of decayed exterior trim, both exterior and interior window damage was observed; The window will need to be fully reviewed, and all repairs completed to include any unseen damage and proper flashing of the window.

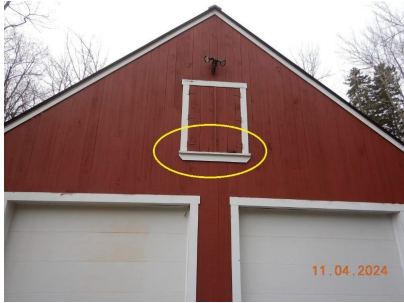
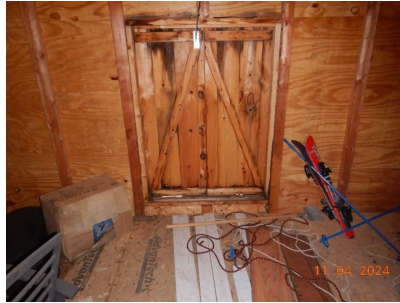
~Decayed Second Floor Hay Loft Door: The decayed hayloft door will need to be repaired and properly sealed to eliminate future damage to the repaired door.

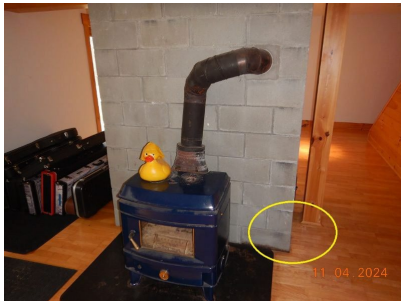
~Moisture Stains And Efflorescence At Chimney Base: Moisture staining and efflorescence at the base of the interior chimney indicates moisture may be entering the top of the chimney or condensation is being created within the chimney; At the chimney inspection and service, the cause will need to be determined to ensure no moisture is entering the chimney or it is past moisture damage.

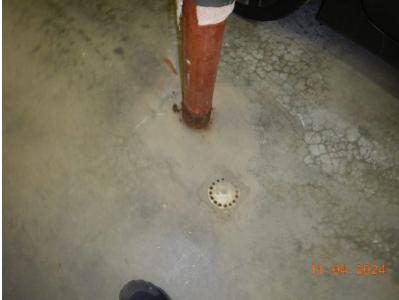
~Rust and corrosion was observed at the base of the metal support post for the garage; This is a condition caused overtime by contact with salt and water runoff from cars and winter driving; The post should be corrected to include reinforcing the damaged metal or replacing the post with a non-corrosive material.

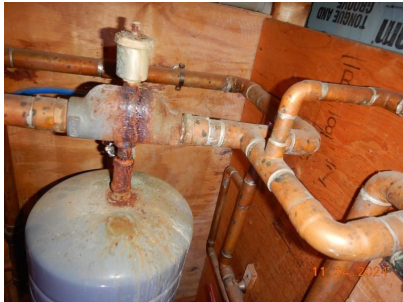
~Leaking High Air Vent(s) and Damaged Expansion Tank: A common condition on boilers is leaking air vents and valves above expansion tanks and distribution lines for the boiler; All of the vents and valves need to be reviewed and corrected to eliminate the leaks and subsequent corrosion on the boiler.

Leaking And Corroded High Air Vent

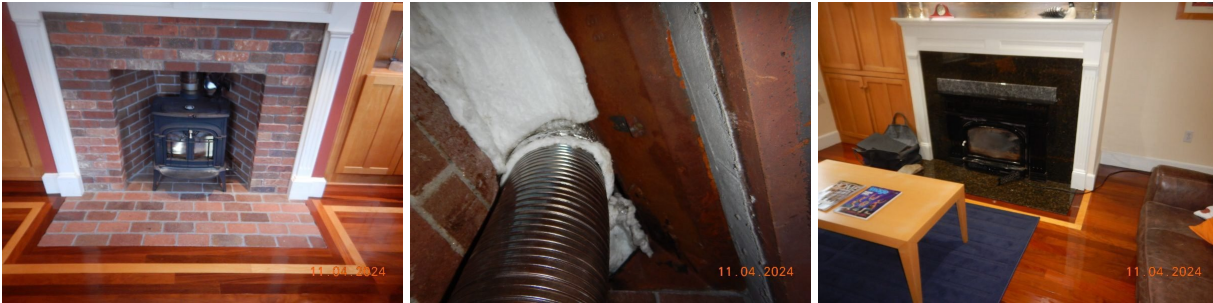
~Hearth: 18 Inches of Hearth Clearance: Wood burning stoves require 18 inches of clearance from all combustible floor surfaces; The hearth will require additional floor protection.

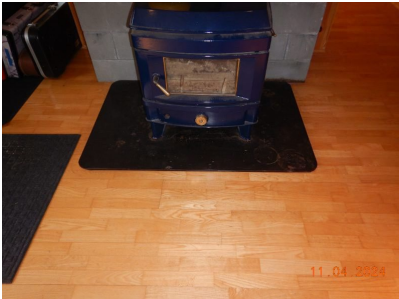
~Hearth: 18 Inches of Hearth Clearance: Wood burning stoves require 18 inches of clearance from all combustible floor surfaces; A properly typed and sized hearth will need to be installed.

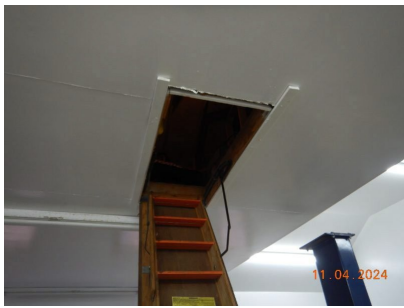
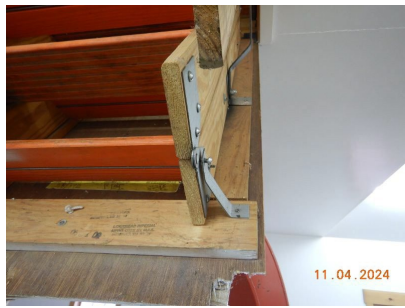
~Pull Down Stairs: Do Not Use Until Corrected: The pull down stairs are improperly secured (minimal and undersized nails) and a step hinge is coming apart; The stair will need to be repaired to include repairing the damaged cover in the stair.

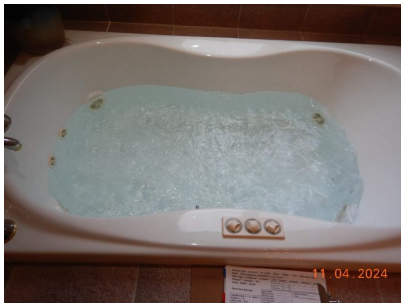
~The tub drains but the drain stopper will not operate and will need to be corrected.

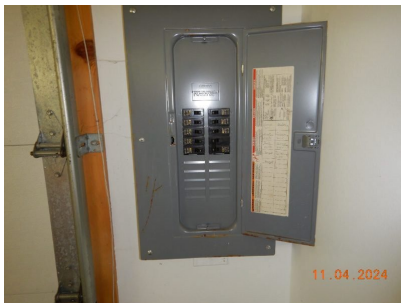
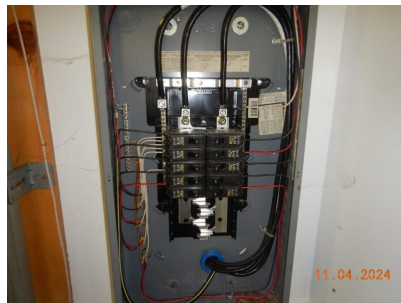
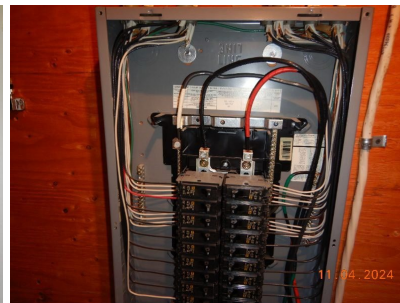
~Screws: Approved electrical panel screws need to be added to the panel.

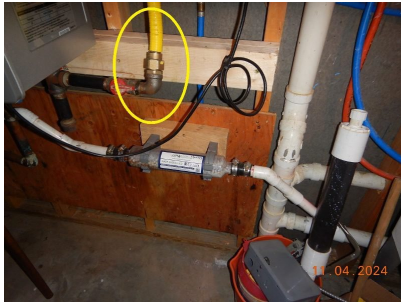
~Yellow Corrugated Stainless Steel Tubing: CSST Propane Lines: For human and lightning safety, proper bonding of the propane gas lines and appliances will need to be installed to ensure the unit and gas piping is properly bonded; Bonding is the permanent joining of metallic parts to form an effective electrical path that ensures continuity and the capacity to safely conduct any current likely to be imposed away from the propane.

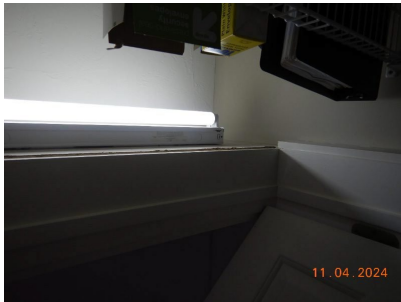
~Open Light Bulbs: Light fixtures in all closet locations need to be properly covered; If not properly protected, open light bulbs pose a fire or breakage hazard in closet areas.
