# River Valley Home Inspections LLC

It was a pleasure completing your property inspection. As you will read, the inspection report consists of a detailed evaluation of different components and elements present in and outside the property with photographs of the property.

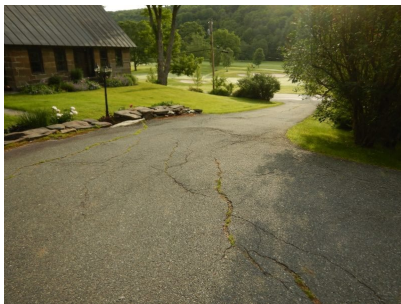
~Asphalt Drive: General: Crack Filling, Sealer: To maintain the optimal condition of asphalt drives, all cracks and separations should be filled, and sealer added to the drive surface.

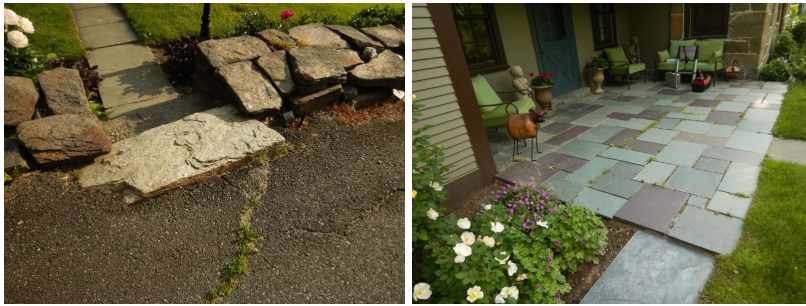
~Grout Flagstone: As a result of prolong moisture and rain contact, the concrete mortar joints need to be renewed to eliminate further decline of the step and landing surfaces over time.

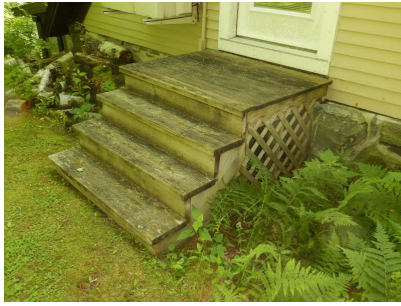
~Cleaning Wood Steps: Slippery Lumber: Steps, landings and decks constructed of wood tend to become very slippery in cold, snowy and damp conditions; Thin coatings of frost and algae on the surface will make it very slippery and prone to falling; The step surface will need to be fully cleaned and some form of abrasive surface should be considered to improve traction on this type of construction.

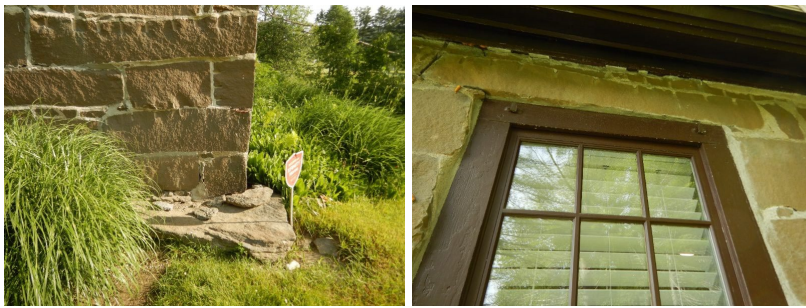
Rear Of Home

~Stone Pointing and Stone Repair: Antique Homes: Review, Maintain and Ongoing: As a result of weather impacts over time, the surface of the mortar joints need to be renewed and sealed to ensure the long term weather envelope of the home: Stone pointing and repair is an ongoing maintenance item on stone homes this age as a result of the sand mortar between the stones and the old/soft mortar type used to construct the home.

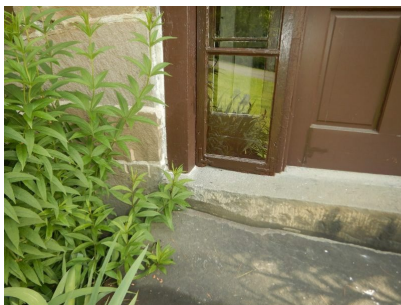
~Lower Trim Areas: Soft and Declining Wood Trim: Full Review Of Home: Areas of the home's lower trim boards have decayed as a result of moisture penetration over time; The trim will need to be repaired and repainted or replaced to avoid further decline of those areas and eventual damage to other parts of the home behind the trim; When repaired, all areas behind the trim will need to be reviewed to determine the extent of the decay and subsequent repair required.

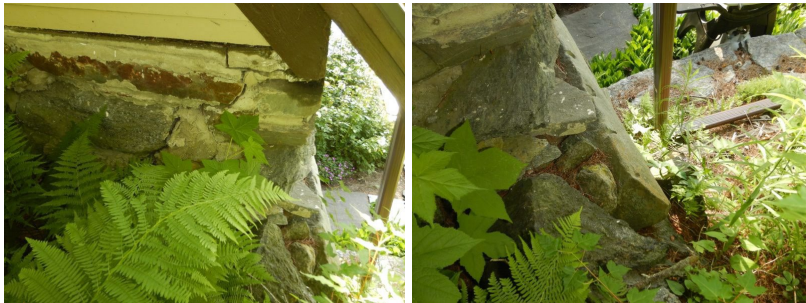
~Stone Foundation Slip: An area of the stone foundation has slipped; The stone foundation will need to be reviewed and corrections completed to strengthen the foundation from further movement to include tuck pointing the stone after repair.

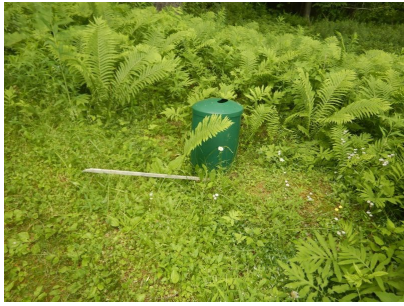
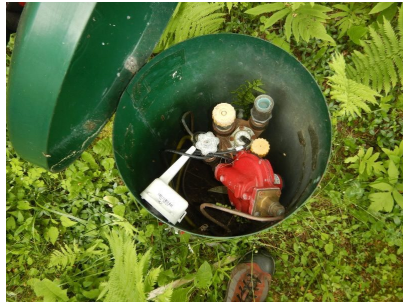
~Propane Tank, Piping and Regulator(s): The propane delivery company will need to be contacted to confirm the propane tank ownership and condition, corrugated stainless steel tubing (CSST) pipe bonding if applicable, meter condition if applicable, and the condition of the lines, shutoffs and regulators serving the home before taking ownership of the system.

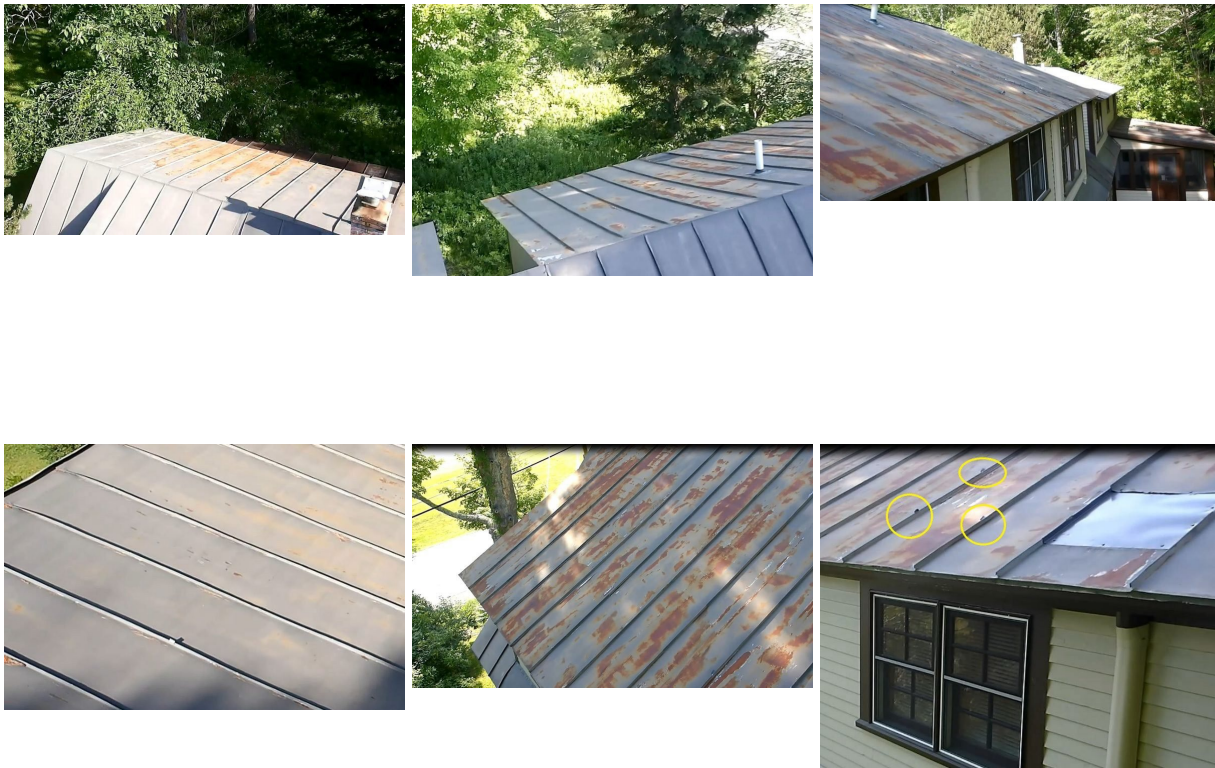
atmospheric impacts on the galvanized roof surface over time; A professional metal roofing painting contractor will need to be consulted about options to address the areas impacted and to ensure the roof is intact and to slow the aging process of the roof panels to include a full review of the roof surface, proper flashing installation and securing any loose roof panels in preparation for coating, repair, or replacement.

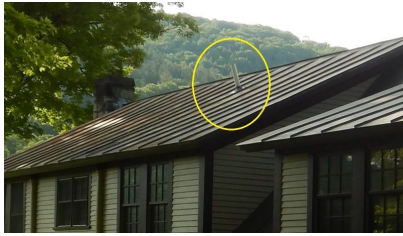
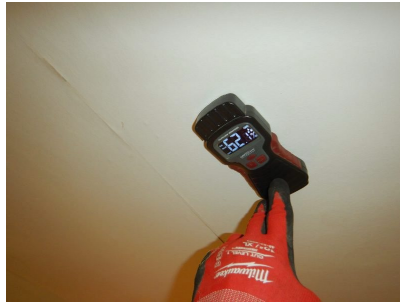
Vent Leaning

~Please see this section: Vent Stacks/Attic Vent Covers notes.

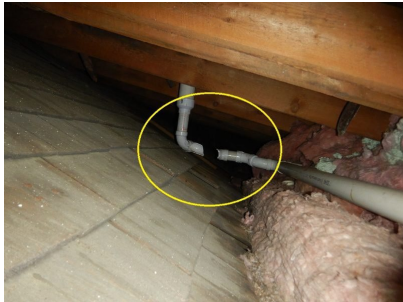
~Vent Stack Leaning/Damage/Disconnected: The sewer vent stack is damaged and will need to be corrected.

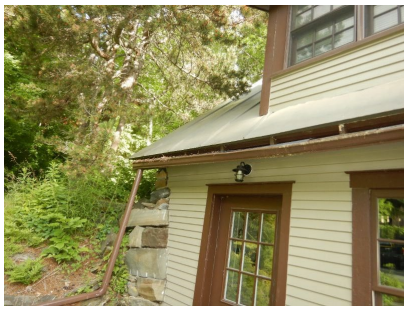
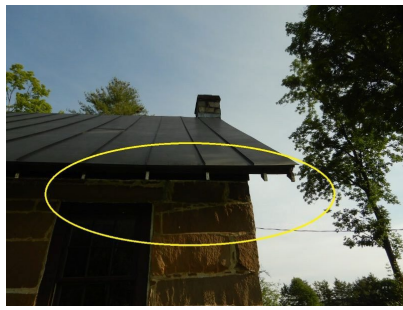
~Stone Basements: To aid in draining roof water runoff from around the home and foundation, gutters may be considered; Gutter type, size and strength is important in this geographic area; Gutters, downspouts and extensions need to withstand snow and ice sliding from roof surfaces and have the ability to catch and carry large amounts of water as a result of steep roof pitches.

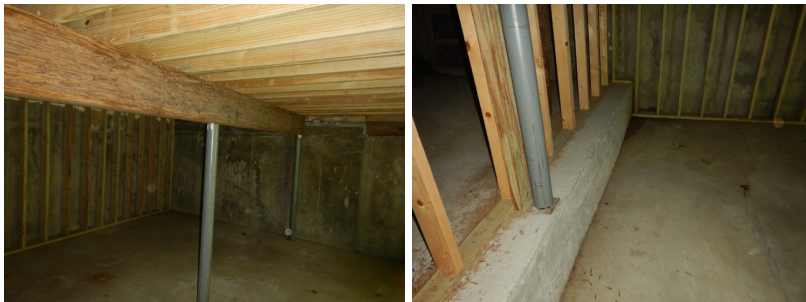
~Dampness was observed along the inside lower walls of the garage; The cause will need to be determined and corrections completed to eliminate the observation.

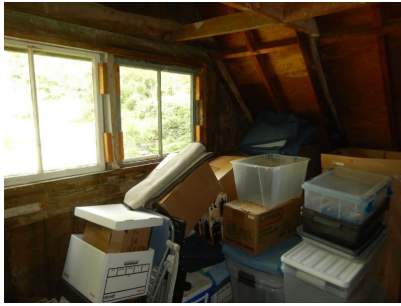
any paint or varnish cans; Labor and removal cost for yard and home clean outs may be substantial dependent on the volume and types of materials removed to include trash in the second floor area.

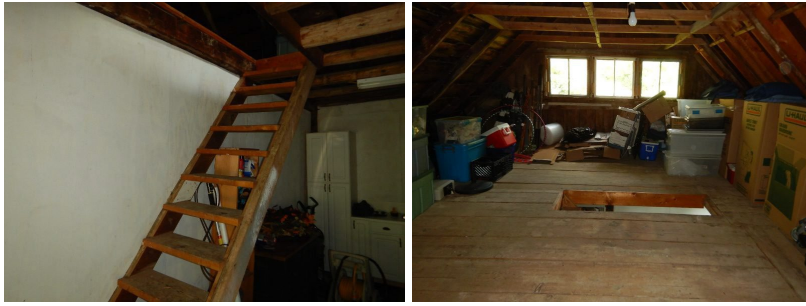
~Open Stairs: Stair riser openings at the rear of the step cannot exceed 4 inches in height; Proper protection of the stair openings will need to be installed.

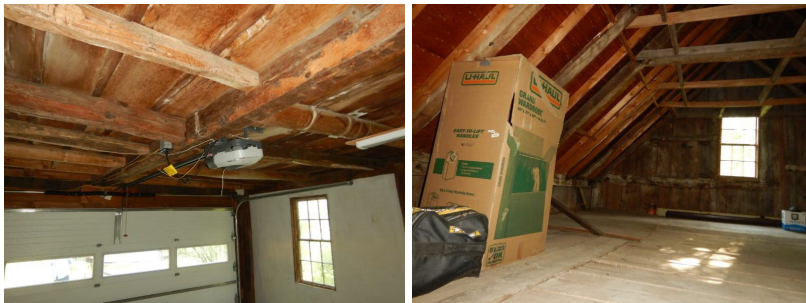
~The second floor storage area is inadequately supported; The floor needs to be properly supported to carry the live floor load and storage of materials in the area; A professional building contractor will need to be consulted about additional methods to support the floor structure.

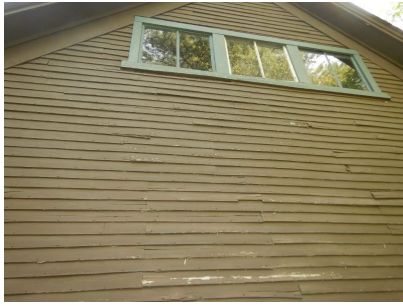
~Siding Decline and Decay: Garage: Baseline Repair and Ongoing: Full Review and Repair: Siding decay and decline was observed along areas of the siding as a result of moisture and snow contact over the years; Wood sided garages need to be reviewed yearly and the damaged siding repaired to eliminate further decline of the remaining siding as well as protecting the structure behind the siding from further damage due to water penetration; Please note: the wall sheathing, 2X4 wall studs and sill behind the siding should be checked for damage when the siding is removed and repaired in these areas if damage is identified; A full review of the garage perimeter needs to be performed and the repairs completed; After the siding is repaired and cleaned, painting will need to be to be completed.

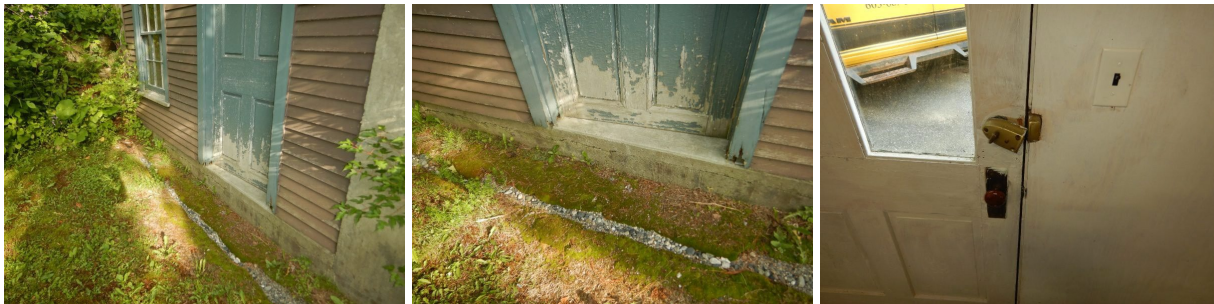
~Door Locks Replaced: As a result of the doors being pushed open, the door locks have been damage and will need to be repaired.

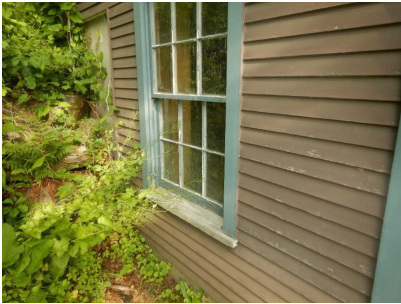
surfaces, freeing stuck windows, adding locks, and adding window stops on those falling shut, and repairing any sill decay when prepping for paint: Repair Versus Replacement: Some customers will explore the cost to replace versus the cost to repair/maintain the current windows; A professional window replacement installation company should be consulted if this strategy is desired.

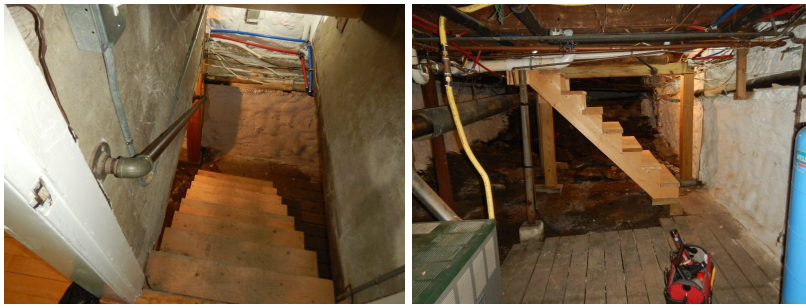
~Tall Last Step: The final step is tall and creates a tripping hazard; The step will need to be corrected.

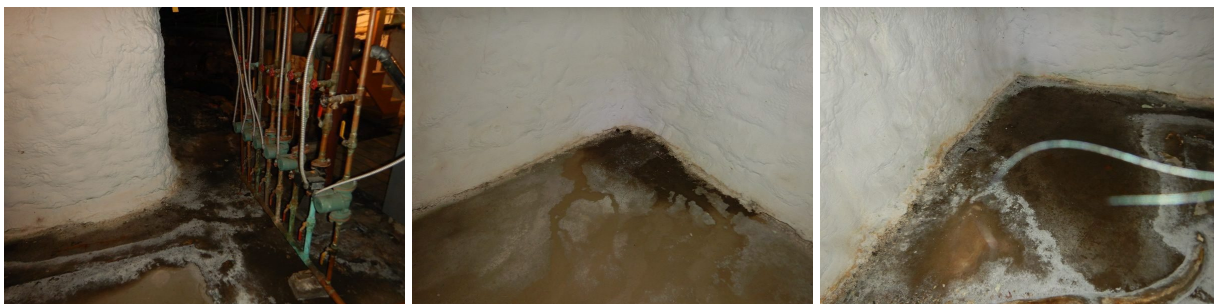
~Basement and Crawlspace Present: Active Dampness and Staining: Enhanced Dehumidification Recommended: Current Relative Humidity Level- 68%: The desired state for basement humidity levels is 45% to not greater than 50%; Higher levels of moisture are common in basements not utilizing dehumidification especially in the summer months; Dampness and moisture was observed along the walls areas and floor areas; After all exterior grading, gutters, vapor barrier added if needed, cold water pipe insulation and proper chimney covers if not installed are completed, an installed dehumidification and or an air exchange unit in the basement will aid in eliminating higher levels of humidity commonly found in basements and crawlspaces; A professional basement moisture specialist will need to be consulted regarding additional methods to eliminate the observations.

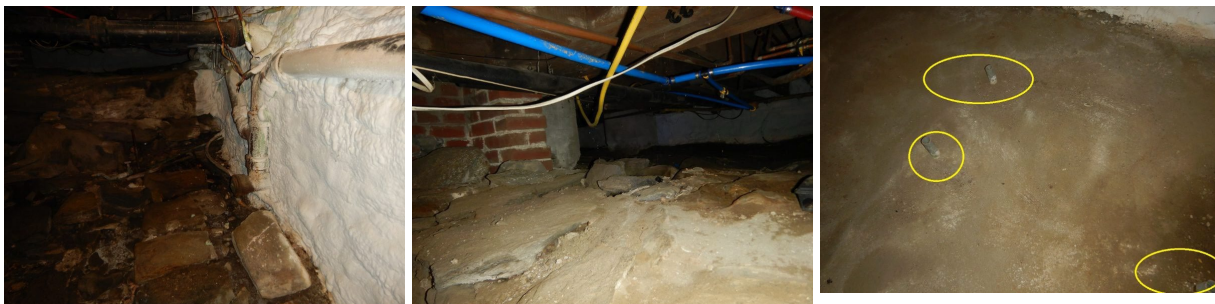
~Dirt Floor Areas: If concrete is not installed, all dirt floor areas should be cleaned and graded; The addition of a vapor barrier on top of the dirt and stone on top of the vapor barrier will help eliminate moisture entering the basement and home from the dirt areas.

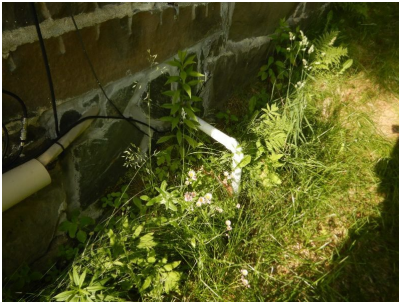
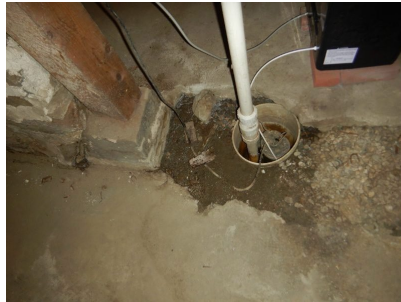
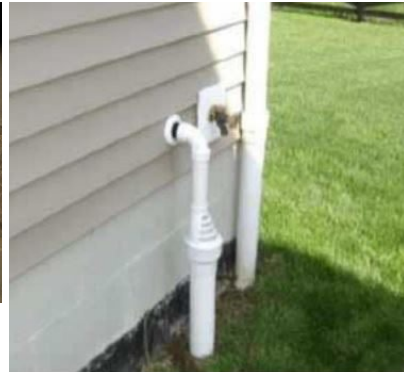
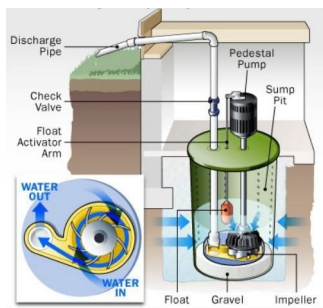
~Appropriate Sump Pump Pit and Plumbing Installed: The sump pump operated when tested but is installed in an incorrectly designed sump pit; The sump pump should be installed in the appropriate sump pump pit with a gravel perimeter and lid and a PVC drain line and all check valves need to be installed; The discharge pipe needs to be properly installed outside the home, insulated for winter use and run to move water away from the home's foundation.

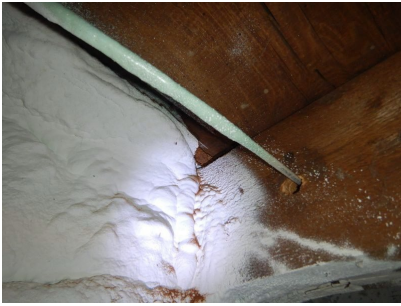
elimination company should be consulted to determine the best approach to eliminate future pest and seal all openings into the home where pest may be entering.

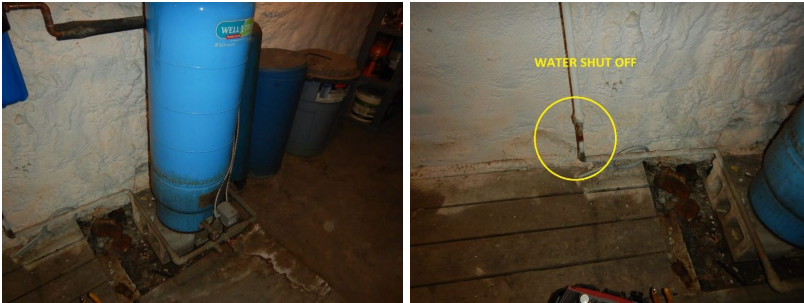
~Well: Pressure Tank, Cleanup, Cold Water Pipe Insulation and Catch-pan: If not in completed, all dirt and debris and any nonessential items should be removed from around the homes water system; The pressure tank area needs to be cleaned; Condensation generated from cold water pipes and humid room conditions, common in this area, drip onto floors and drop ceilings if installed; Insulating cold water pipes and adding a drip catch pan below the well pump pressure gauge and piping area at the base of the tank will help lessen this impact.

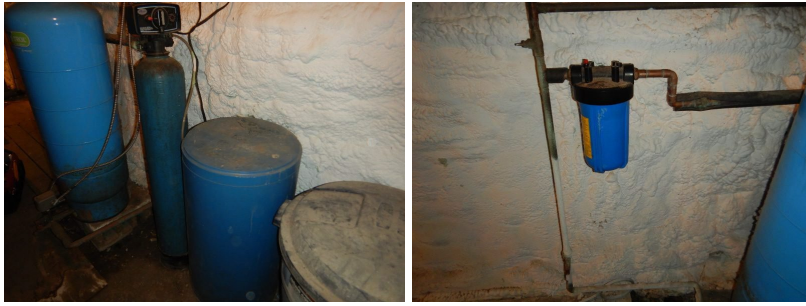
~Canister Filter: The filters cartridge should be changed per manufacturers recommended intervals; If a red or sometimes blue button is present on the top of the filter housing, the button will need to be pressed after closing the water supply to the filter to release pressure.

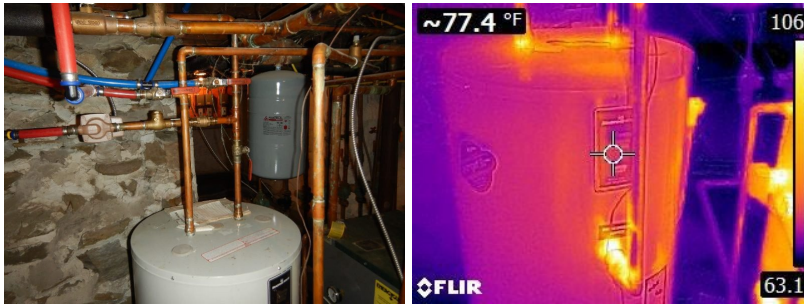
IR Hot Water Heater Operation

~VT: Thermal Mixing Valve Not Installed: Vermont requires the installation of a thermal mixing valve on all hot water heaters installed after 2005 to include on demand units; A licensed plumber will need to be consulted for the proper installation of the thermal mixing valve.

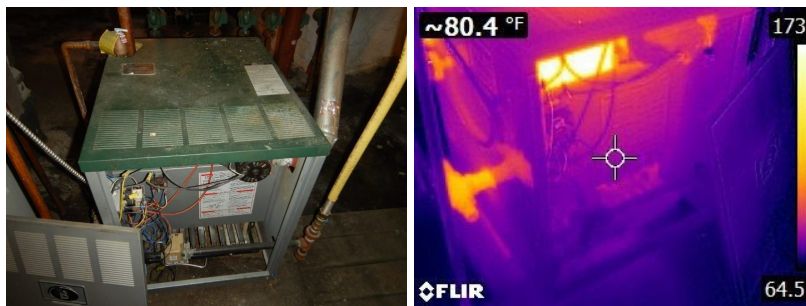
IR Boiler Operation Heat Tracing

~2024/25 Heating Season Servicing: Service Plans: Last service date tag- 2/2024: To set the baseline operating condition of the boiler before taking possession of the equipment, the boiler need to be fully serviced; It is recommended a professional heating contractor be consulted to have the boiler serviced and fully cleaned; In addition, the boiler shroud, and all connecting sensors and pipes inspected for corrosion and scale; Propane fired boilers should be serviced every year to ensure the exhaust and mechanical workings of the boiler are in satisfactory operating condition; In many cases, if available for the boiler, home owners will join a service plan or home warranty service to have the boiler protected for emergency repairs and service.

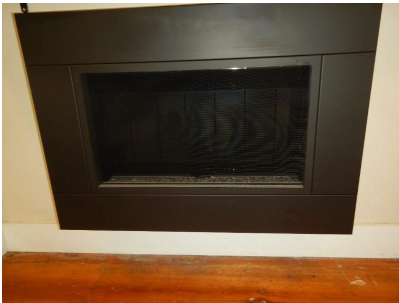
~Gas Fireplace: Cleaning and Service: Off And Not Operating: Like any combustibile fuel home heating appliance and in preparation for the upcoming purchase of the home and heating season, the unit will need to be serviced to include vacuuming and cleaning of all dust collected below the unit, the glass front cleaned if applicable, and all exhaust components of the unit inspected to ensure they are operating correctly.

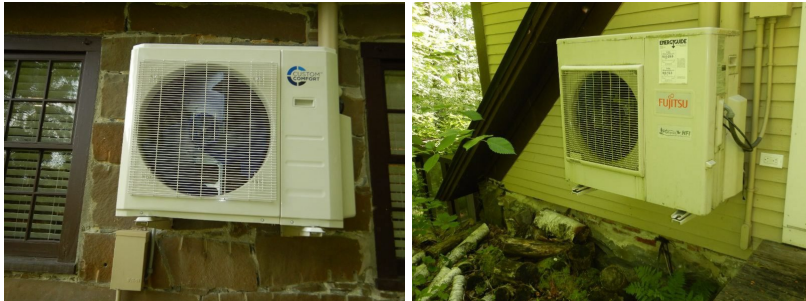
~Full System Service: Operational: No Last Service Date Indicated: The home's secondary heating and primary cooling needs are limited to specific areas of the home and are completed by an installed heat pump system; Like any heating and cooling appliance, yearly maintenance on the unit before taking possession of the unit is important to the continued operation and efficiency of the unit's operation; A heating and air conditioning service company will need to be consulted about the yearly inspection and maintenance of the units to ensure they are operating at peak heating and cooling efficiency.

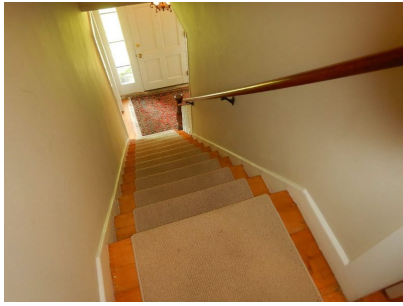
Front Stair

~Steep Stairs: Step Risers and Short Treads: The current step risers are tall, and the treads are short creating a steep staircase; A common condition on staircases, some customer's elect to rebuild the stairs to meet current stair requirements; If not corrected, caution should be exercised when using the steps.

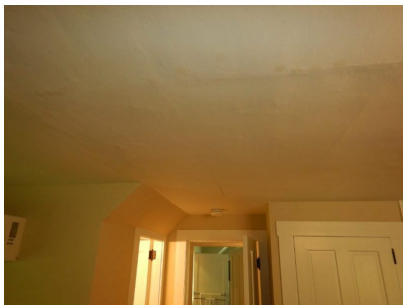
~Plaster Ceiling Damage Center Room: As a result of the moisture damage, the ceiling will need to be repaired.

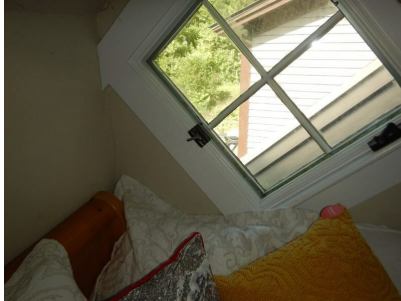
~Missing Screens: Screens were observed missing from multiple windows; All of the screens should be requested to be installed or placed in front of the windows (winter) to determine if any are missing or damaged and those missing or damaged be repaired or replaced where needed.

Window Not Latching

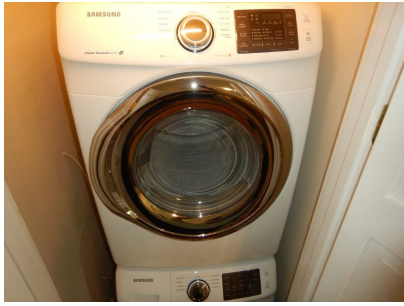
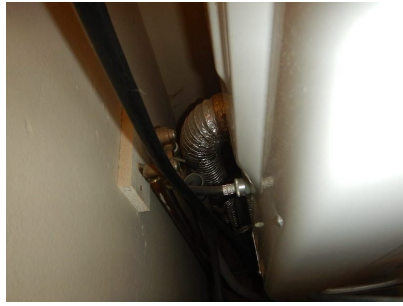
~Important Fire Protection Maintenance: At Purchase and Ongoing: Washer and Dryer Behind and Under Unit Clean-up: As an important maintenance task for fire prevention, the areas behind the washer and dryer cleaned and vacuumed of all lint, dust and objects that find their way behind the units over time; The dryer vent and all connecting venting hoses should be cleaned and if plastic vent pipes discovered replaced with metal and the termination point outside the home confirmed; The clothing washing machine plumbing and drain connections should be reviewed for proper installation and shut off ability; The clothing washing machine is not tested as part of the inspection due to the possibility of leaving water in the unit; Verification of the units operability should be made with the seller if the unit is part of the sale.

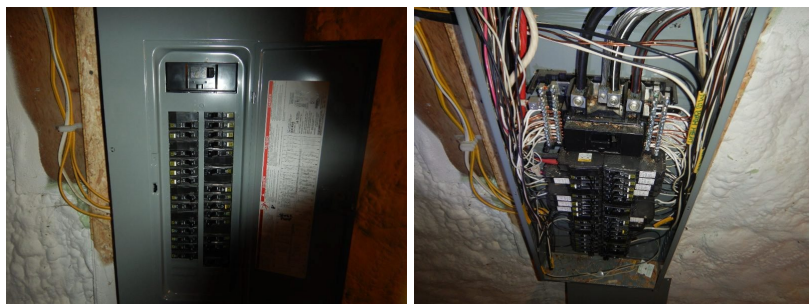
~Sub Panel Designation: As a result of the service disconnect location at the meter, the main electrical panel needs to be corrected to meet sub-panel grounding and bonding wiring requirements.

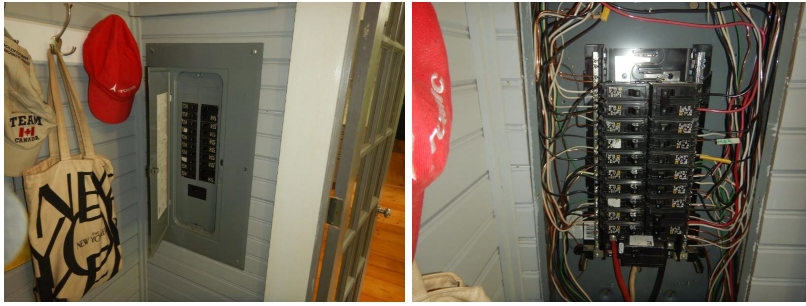
~Sub Panel Designation: As a result of the service disconnect location, the electrical panel needs to be corrected to meet sub-panel grounding and bonding wiring requirements.

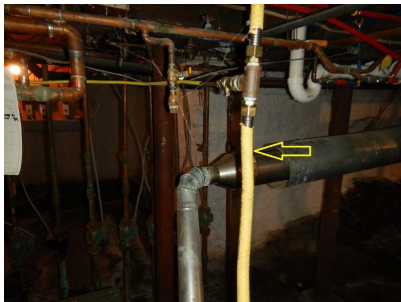
~Yellow Corrugated Stainless Steel Tubing: CSST Propane Lines: For human and lightning safety, proper bonding of the propane gas lines and appliances will need to be installed to ensure the unit and gas piping is properly bonded; A relatively simple installation, bonding is the permanent joining of metallic parts to form an effective electrical path that ensures continuity and the capacity to safely conduct any current likely to be imposed away from the propane; The propane delivery company will need to be contacted regarding responsibility of the installation.

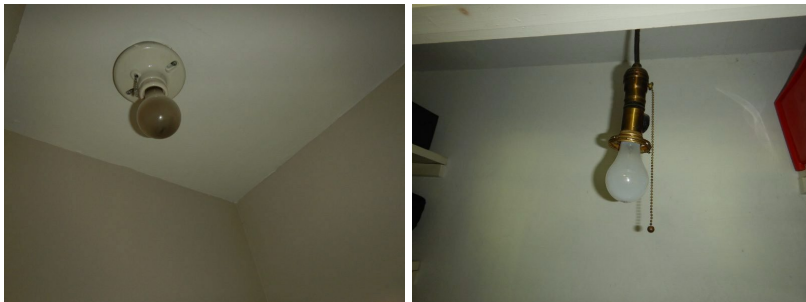
~Open Light Bulbs: Light fixtures in all closet locations need to be properly covered; If not properly protected, open light bulbs pose a fire or breakage hazard in closet areas.
