# River Valley Home Inspections LLC

# Summary

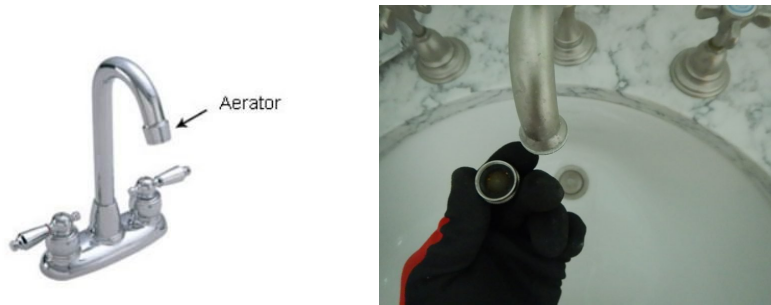
~Clean Sink Aerators and Shower Head Water Ports: To improve general water pressure, cleaning sink aerators of debris and scale and cleaning shower heads of scale will improve water pressure.

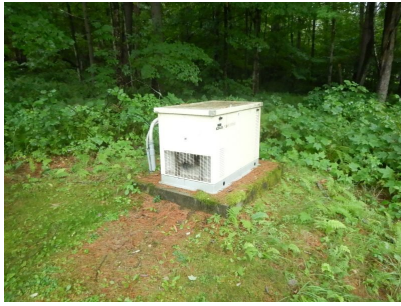
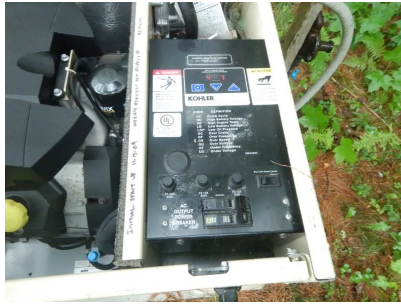
\*Service Date: Last service date tag was observed: 9/19.
