River Valley Home Inspections LLC

David M. DeSimone
ID: Board Certified and Licensed in NH and VT
244 Town Shed Road
Orford, NH 03777

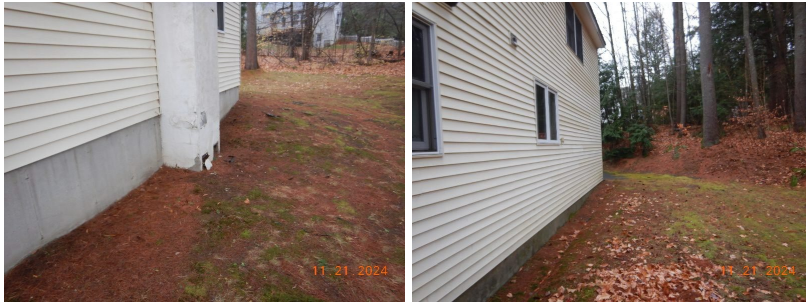
~General Grading Needs: The grade along the perimeter of the home is an important factor in keeping moisture away from homes and allowing water to flow away from the home's siding, sills and foundation; A plan should be implemented to upgrade the current grading along the foundation including the walk out door area if present and any planting beds of the home; Grading first with vapor barrier with stone on top should be added to allow water to flow away from the foundation and limit dirt and water splashing onto the siding of the home; The top of the stone border should be at least 6 inches below the edge of the siding when establishing the grade of 5/8th inch pitch per foot fall and/or drained to move water away from the foundation; If unseen decay is discovered in the course of grading improvements, any impacted siding will need to be addressed to include ensuring the sill and wall studs are intact behind the siding.

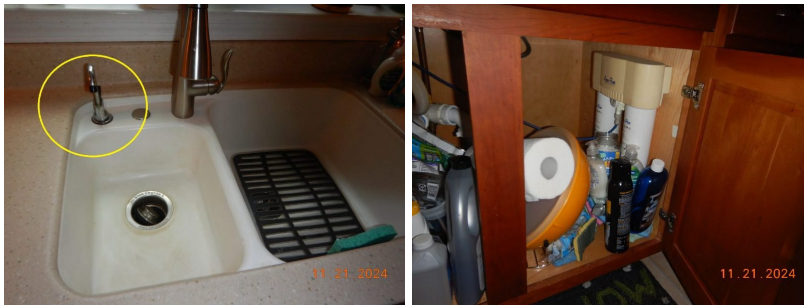
~Point Of Use Water Filter: Baseline Filter Reset: A point of use water faucet was observed at the kitchen

sink; The below sink filter should be changed and maintained at the manufacturers recommended changes going forward.
