River Valley Home Inspections LLC

David M. DeSimone
ID: Board Certified and Licensed in NH and VT
244 Town Shed Road
Orford, NH 03777

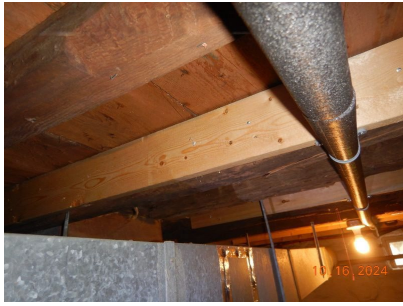
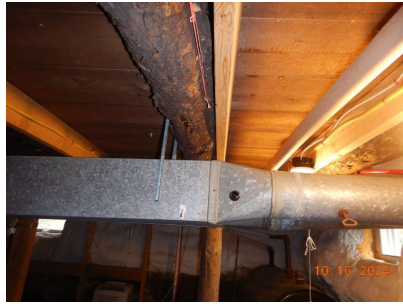
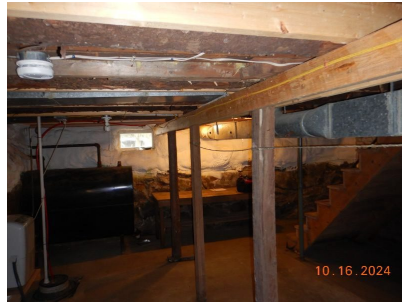
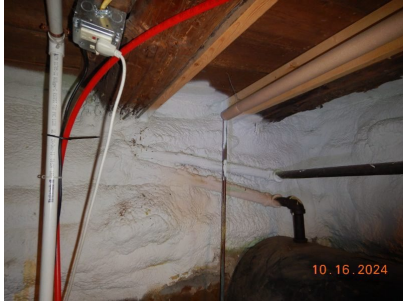
~An extensive amount of reconstruction work has been completed in the basement area of the home to address decayed and undersized floor joist and beams, and to stabilize the floor structure including floor joist, beam and post support; The upper floor structure, however, was not leveled and the floor sag remains in areas of the first and second floor of the home; This condition is common for home this age and if corrected will create significant repair needs to existing walls and trim; If the floors are leveled through jacking of basement and first floor ceiling beams, the work, that may include pier upgrades, will need should be completed before the upper floors' renovation work; Alternate options to include floor removal and leveling may be utilized to correct the condition; Professional building contractors are available to assess the options available to level the floors if desired.

~Insulation Installed: Sill, Sill Plate, Floor Joist Connections, and Subfloor: As a result of installed insulation, the areas were not fully inspected; The areas that are exposed are in satisfactory condition.

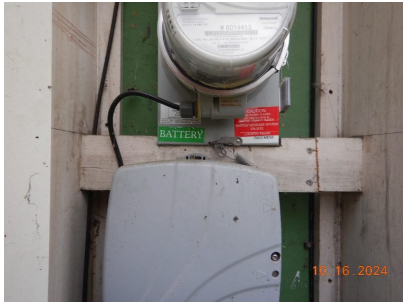
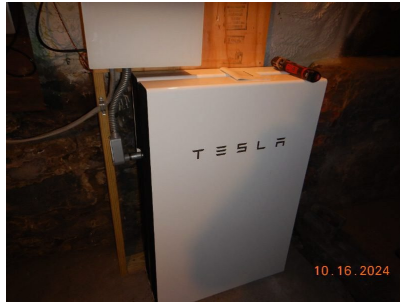
~Tesla Wall Battery Backup Gateway: The home is equipped with a Tesla wall battery system backup gateway to the electric utility; These systems typically allow for backup battery generation of 10 to 12 hours for customer use dependent on connected load and the utilities ability draw from the power source during peak demand use periods when needed; The utility serving the home will need to be contacted to determine the requirements in place for use, customer responsibilities and customer impacts of the system; The unit is inspected for exterior defects and item blocking the equipment; The unit is not live tested as part of the home inspection scope; A licensed electrical contractor or the utility servicing the system will need to be consulted about the current service status, emergency response availability, verification of the units operation, all connecting service wires, the electrical circuits and systems supported by the generator and all transfer switching off and back onto the utility service.
