River Valley Home Inspections LLC

David M. DeSimone
ID: Board Certified and Licensed in NH and VT
244 Town Shed Road
Orford, NH 03777

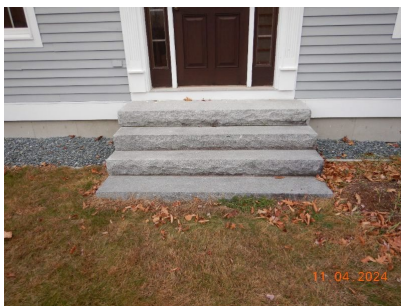
~Stairs Less Than 30 Inches From Grade: Stairs into homes with 4 or more risers and less than 30 inches from grade requires a graspable rail on one side of the stairs; A professional building contractor should be consulted about the various options to make the stairs safe.

~Landing Pad Added: An important addition at the bottom of a steps or stairs from a home is the addition of a landing pad; Landing pads allow for the safe stepping into or out of homes or onto and off stairs.

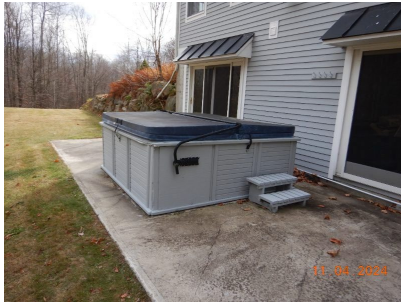
CN/Sl.

~Spa Installed At Home: While not a part of the home inspection agreement scope, safety features for spa installation has advanced to include specific home and water entrance alarms as well as locking spa covers and other safety features installed to keep individuals from entering spas accidentally when not monitored or in use; It is recommended to have the spas current safety features reviewed to include all spa electrical grounding systems, current safety features and new advancements in spa safety explored for implementation.

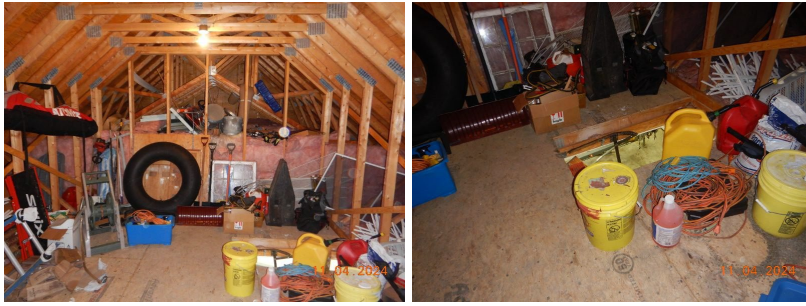
Attic.

~Full Cleanout: The attic needs to be fully cleared of all debris and any stored items not remaining in the structure.

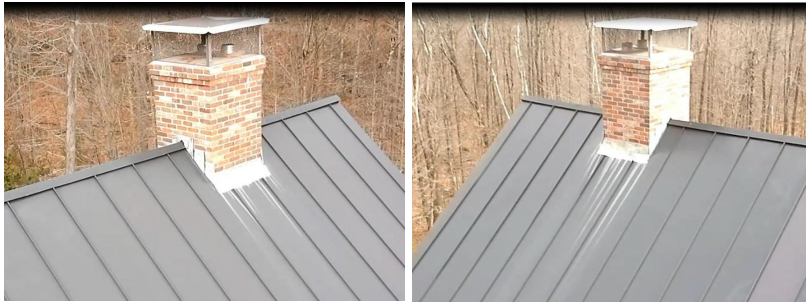
PC.

~Covers Installed: Exterior Satisfactory: Condition Inspection, Cleaning, and Liner Determination: The exterior chimney (s) were observed in overall satisfactory condition; Visual observation is not enough in the case of chimneys and a professional chimney service should be consulted for the interior inspection and cleaning of the chimney (s) before use if not completed this year including determining if a liner is required based on the chimneys condition; The chimney flashing (metal), counter flashing and crown will need to be inspected as part of the chimney service to ensure no water is entering the home from this area of the chimney.

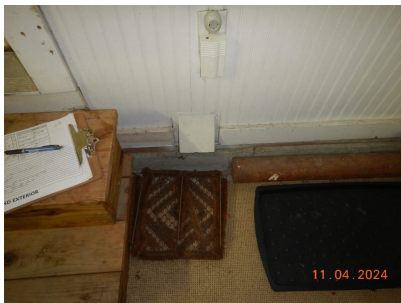
Vent Near Step Into Home.

~Mechanical Penetrations Like Piping and Vents: All adjoining walls and ceilings to the living space needs to be sealed to slow the spread of flames and fumes from the garage; Any gaps or other penetrations need to be properly fire protected; Several types and methods are available to include fire approved spray foam sealants, Rock-wool insulation, expanding pipe collars, etc; All manufactures installation requirements will need to be followed to properly protect the interior home and its occupants; A professional building contractor should be consulted about the proper material types and methods available to accomplish this safety feature.

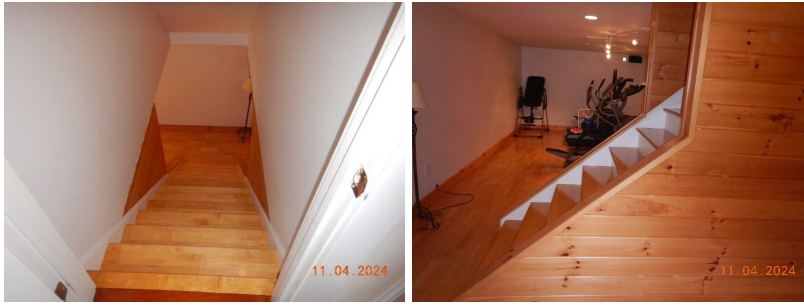
~Grasp Rail Missing: Basement stairs require the installation of an approved grasp rail that can be firmly grasp the full length of the stairs at least 34 to 38 inches in height to aid individuals climbing and descending stairs; The current rail is missing and will need to be installed.

~Guards Added: Open Stair Sides: Appropriately spaced guards (balusters no more than a 4 inch sphere passing through, cables, panels or a wall structure) needs to be installed on the open areas leading into the basement along the steps where the steps are more than 30 inches from the floor surface; Guard systems protect individuals from falling through or off the side of stairs in the event of a trip or fall down the stairs.

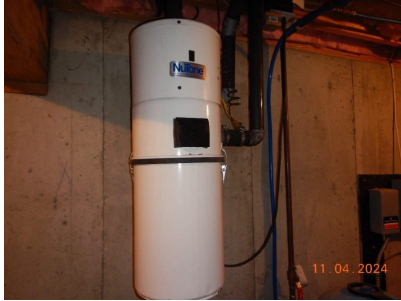
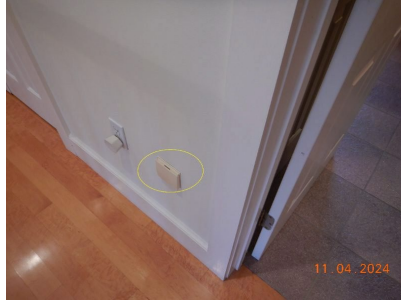
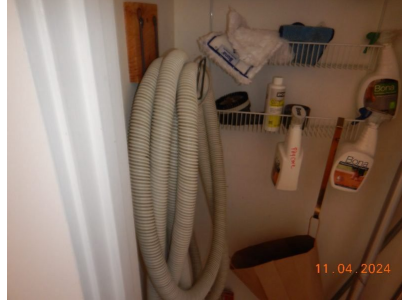
CN.

~Central Vacuum System: Running: Attachments Located: The home is equipped with a central vacuum system: While not inspected as part of the inspection scope, the unit turned on and was operating; The supporting attachments for the unit were in the closets and their operability will need to be verified; The systems require maintenance to include the emptying and cleaning of the dirt collection bin and filter associated with the vacuum system found at the base of the motor.

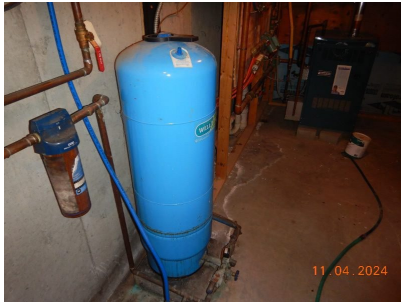
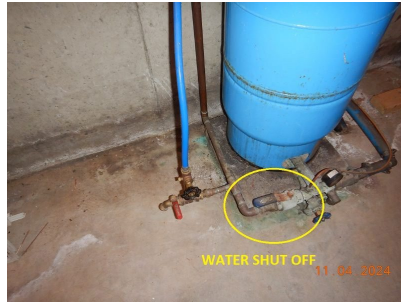
BP.

~Well: Pressure Tank, Cleanup, Cold Water Pipe Insulation and Catch-pan: If not in completed, all dirt and debris and any nonessential items should be removed from around the homes water system; The pressure tank area needs to be cleaned; Condensation generated from cold water pipes and humid room conditions, common in this area, drip onto floors and drop ceilings if installed; Insulating cold water pipes and adding a drip catch pan below the well pump pressure gauge and piping area at the base of the tank will help lessen this impact.

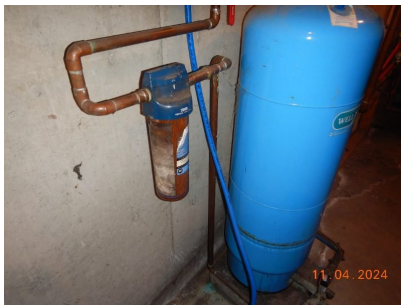
CN.

~Canister Filter: The filters cartridge should be changed per manufacturers recommended intervals; If a red or sometimes blue button is present on the top of the filter housing, the button will need to be pressed after closing the water supply to the filter to release pressure.

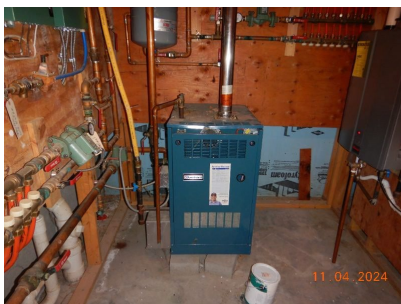
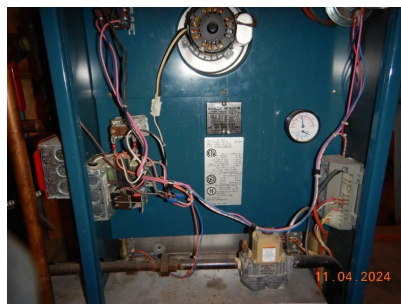
PC.

~2024/25 Heating Season Servicing: Service Plans: Last service date tag- 2017: To set the baseline operating condition of the boiler before taking possession of the equipment, the boiler need to be fully serviced; It is recommended a professional heating contractor be consulted to have the boiler serviced and fully cleaned; In addition, the boiler shroud, and all connecting sensors and pipes inspected for corrosion and scale; Propane fired boilers should be serviced every year to ensure the exhaust and mechanical workings of the boiler are in satisfactory operating condition; In many cases, if available for the boiler, home owners will join a service plan or home warranty service to have the boiler protected for emergency repairs and service.

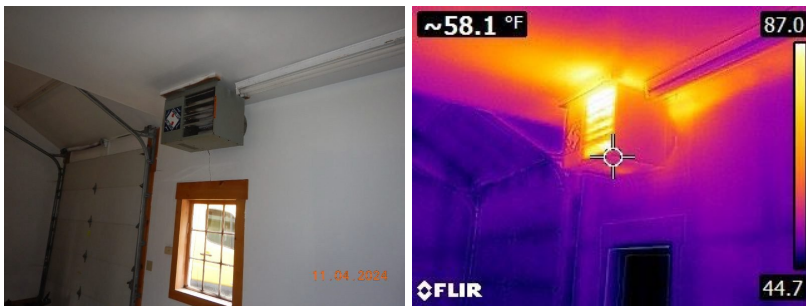
Ceiling Modine.

~2024/2025 Heating Season: Service and Last Service Date Tag- Not Determined; The furnace fired and ran during the inspection process; To set the baseline operating condition before taking possession of the furnace and in prep for the current and upcoming heating seasons, it is recommended a professional heating contractor be consulted to have the furnace fully serviced, cleaned, efficiency rated and verification of the recent servicing documented; In addition, the furnace shroud, and all connecting pipes should be cleaned of corrosion and scale and the interior vacuumed and the unit wiped down to eliminate dirt and debris on the boiler surfaces; Gas fired furnaces should be serviced every year to ensure the exhaust fans and mechanical workings of the furnace are in satisfactory condition.

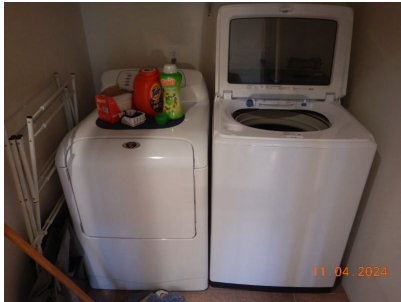
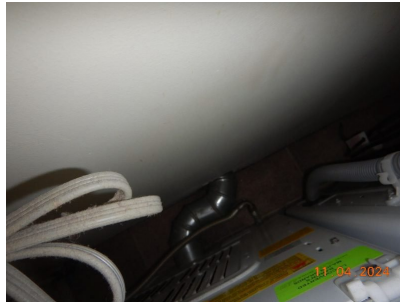
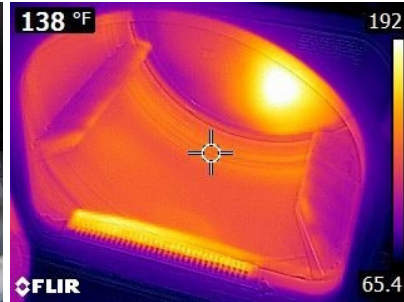
SI.

~Important Fire Protection Maintenance: At Purchase and Ongoing: Washer and Dryer Behind and Under Unit Clean-up: As an important maintenance task for fire prevention, the areas behind the washer and dryer cleaned and vacuumed of all lint, dust and objects that find their way behind the units over time; The dryer vent and all connecting venting hoses should be cleaned and if plastic vent pipes discovered replaced with metal and the termination point outside the home confirmed; The clothing washing machine plumbing and drain connections should be reviewed for proper installation and shutoff ability; The clothing washing machine is not tested as part of the inspection due to the possibility of leaving water in the unit; Verification of the units operability should be made with the seller if the unit is part of the sale.

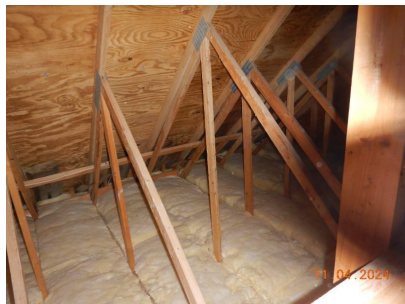
PC.

~Properly Installed Venting: To provide the best venting conditions for attic spaces, the installation of attic soffit baffles and soffit vents is recommended to allow heat to move effectively out of attic spaces during the summer months and moisture out in the winter.

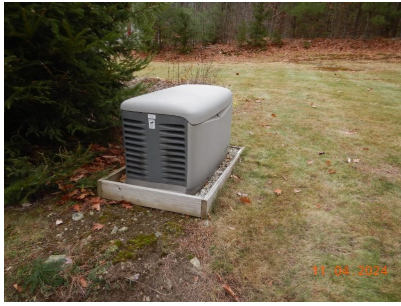
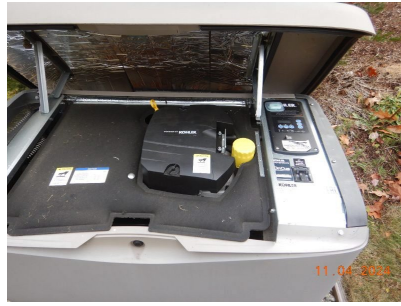
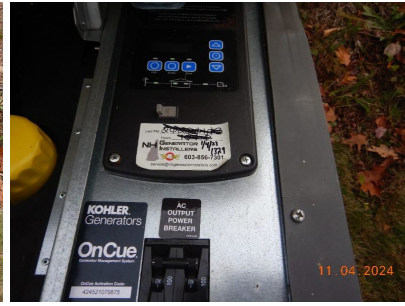
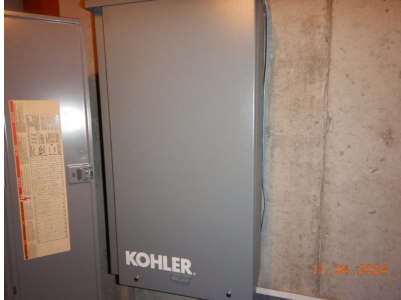
~Standby Generator: Auto Transfer Switch; Active Control Status: The home is equipped with a 18 kW propane fired exterior power generation unit and auto transfer switch gear at the electrical panel in the basement; The unit is inspected for exterior defects, vegetation blocking air intake ports, and last service date indications; The unit is not live tested as part of the home inspection protocol; Last Service Date: 1/23. A licensed electrical contractor or service company servicing the generator should be consulted about the current service status and verification of the units operation, all connecting service wires, oil condition, the electrical circuits and systems supported by the generator and all transfer switching off and back onto the utility service.

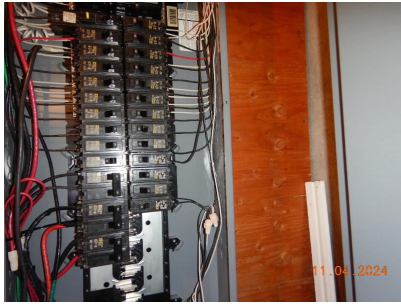
~Screws: Some Missing: Approved panel screws need to be installed in all panel cover slots.

~Labeling Verification Baseline Confirmation and Reset: The panels labeling needs to be updated to confirm or correct the labeling to match current use areas of the home.

~New construction requirements are in place and the electrical panel will need to be reviewed by a Licensed Electrician to perform the identified recommendations or other repairs identified by them in their assessment; In some cases, a need to upgrade the panel will be made based on the ability of the panel to accommodate the identified recommendations.

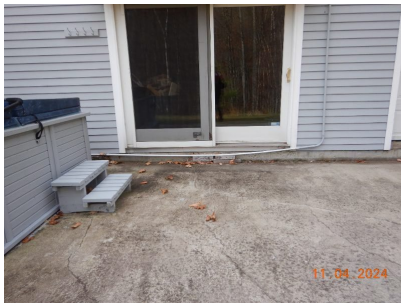
~Exterior Installed Not Operating; The exterior GFCI is installed but will not trip test indicating a failed switch; After repair, a full review of all exterior outlets will need to be performed to ensure the repair has not impacted another outlet.

~Loose Conduit: The loose conduit on the side of the home needs to be properly secured.

~Spa: All Spa Equipment Review and Grounding Confirmation: A full review of all spa associated electrical panels, GFCI's and conduit and connection requirements needs to be completed with ongoing yearly reviews due to the importance of maintaining a safe spa environment.

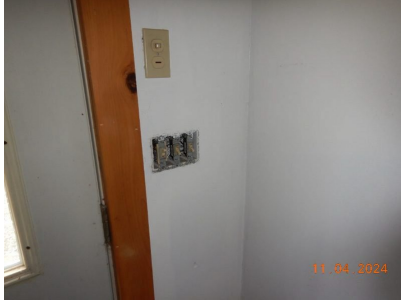
~Missing cover plates on electrical junction boxes were observed and will need to be properly covered.

~Interior GFCI's: Installed But Not Operating: All interior electrical receptacles require GFCI protection; When tested, some outlets did not trip off; A full review of all of the plugs will need to be performed to

ensure the plugs are operational after the repairs are made.
