# River Valley Home Inspections LLC

It was a pleasure completing your property inspection. As you will read, the inspection report consists of a detailed evaluation of different components and elements present in and outside the property with photographs of the property.

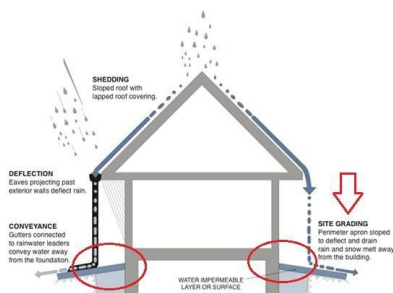
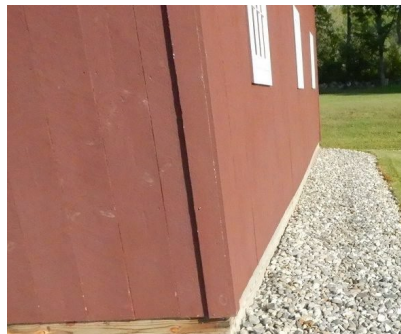
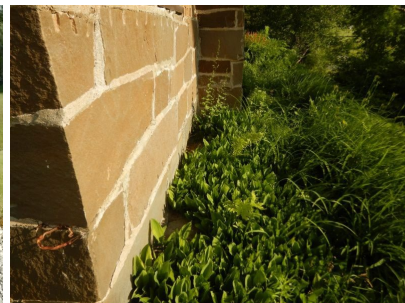
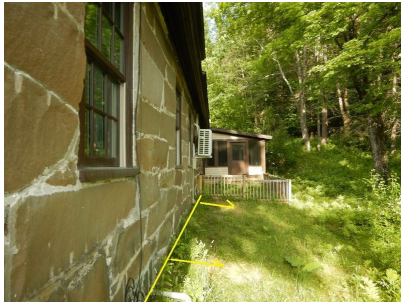
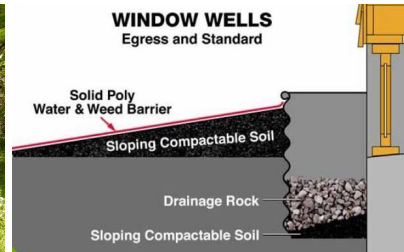
~Ongoing General Grading Needs: The grade along the perimeter of the home is an important factor in keeping moisture away from homes and allowing water to flow away from the home's siding, sills and foundation; A plan should be implemented to upgrade the current grading along the foundation including the walk out door area if present and any planting beds of the home; Grading first with vapor barrier with stone on top should be added to allow water to flow away from the foundation and limit dirt and water splashing onto the siding of the home; The top of the stone border should be at least 6 inches below the edge of the siding when establishing the grade of 5/8th inch pitch per foot fall and/or drained to move water away from the foundation.

~Window Wells Installed: New: Where Applicable: As part of the grading improvement and to aid in the drainage of water away from basement window openings, window wells may be installed with a base of 6 inches of stone and covers or small roof structures to block snow and rain from the window well openings.

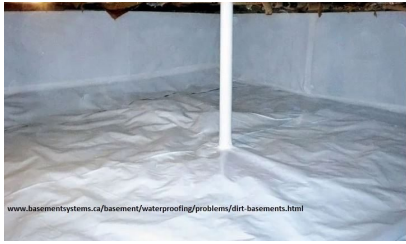
Basement Encapsulation

~Basement and Crawlspace Present: Active Dampness and Staining: Enhanced Dehumidification Recommended: Current Relative Humidity Level- 68%: The desired state for basement humidity levels is 45% to not greater than 50%; Higher levels of moisture are common in basements not utilizing dehumidification especially in the summer months; Dampness and moisture was observed along the walls areas and floor areas; After all exterior grading, gutters, vapor barrier added if needed, cold water pipe insulation and proper chimney covers if not installed are completed, an installed dehumidification and or an air exchange unit in the basement will aid in eliminating higher levels of humidity commonly found in basements and crawlspaces; A professional basement moisture specialist will need to be consulted regarding additional methods to eliminate the observations.
